Natural Streambank Restoration

June 21, 2005

Upper Cattaraugus Creek Stabilization Project

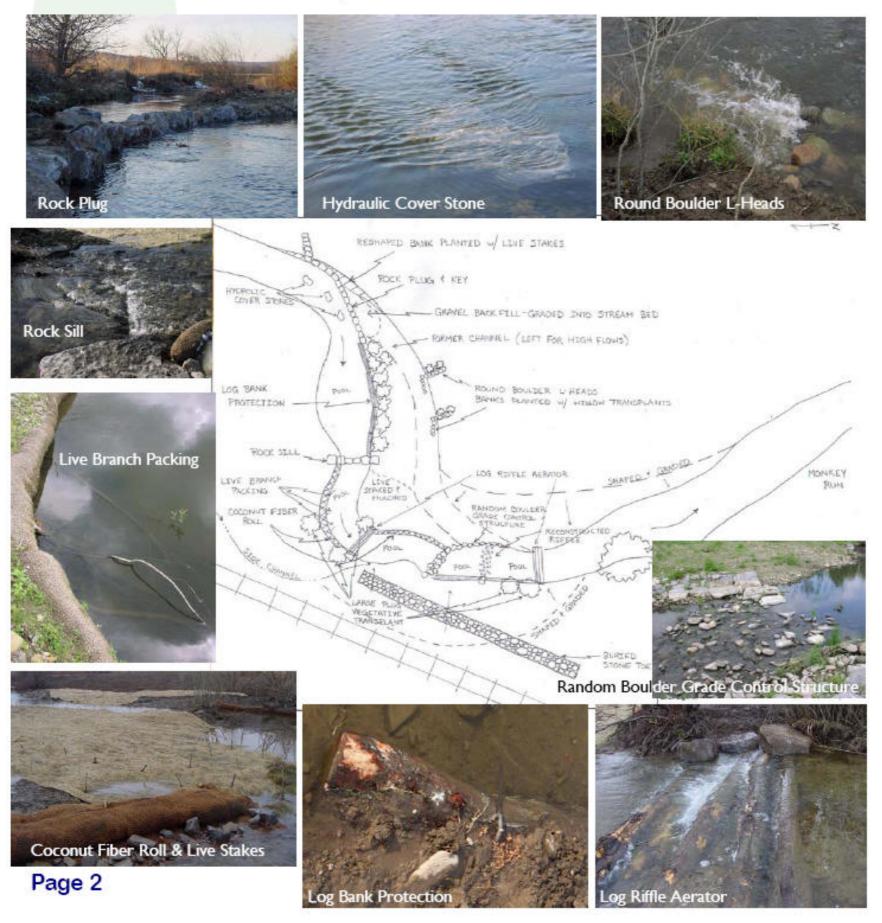
On the next three pages are pictures and drawings of the restoration practices that were installed or plan to be installed. Many of these practices have been installed on rivers and streams much larger than Monkey Run and have been modified to fit the smaller flow stream. Some of the

practices were installed here for the first time in New York. The Rock protecting to Plug, L-Heads and Hydraulic Cover The recreated Stones are used to redirect the flow Riffle Aerated of water. The Vegetative Transboulder Graplants, Coconut Fiber Rolls, Longitudesigned to dinal Stone Toe, Log Bank Protection, Erosion Blankets and Live fish habitat.

Stakes are for reducing erosion by protecting the banks and flood plain. The recreated Pools and Riffles, Log Riffle Aerators, Rock Sill and Random Boulder Grade Control Structure are designed to maintain the stream bottom elevation and provide improved fish habitat.
