Oatka Creek Stream Stabilization and Habitat Restoration Project Narrative

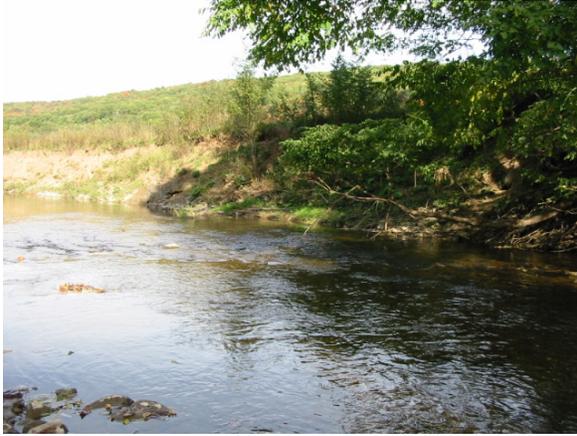
Picture of bank below bridge in 2004

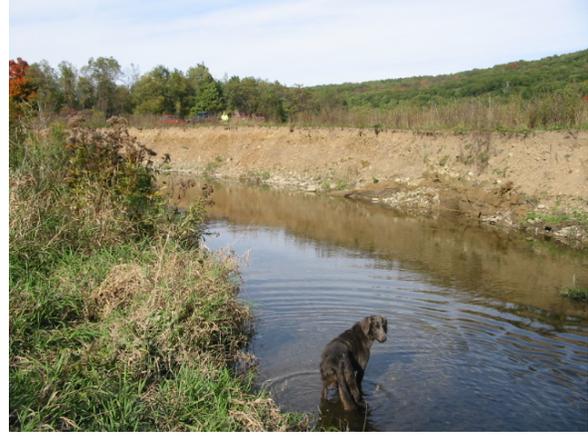
Bank area where original design was to protect as see in 2004

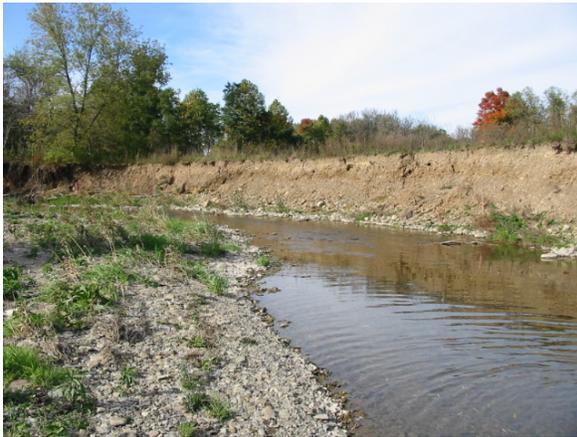
Lower section of that same bank that was eroded out and under cut in 2007 as it was in 2004

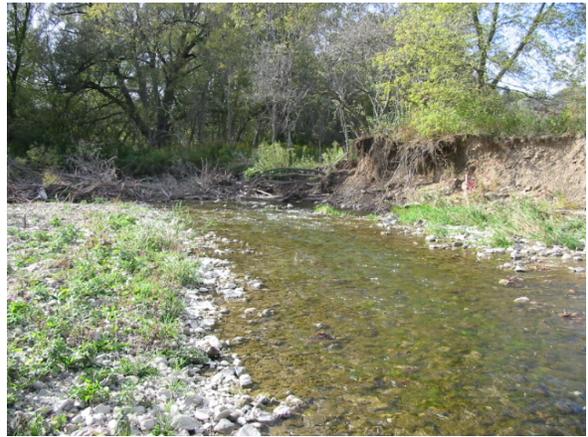
Area where debris collected in sharp bend at the end of our bank to cause the spring blow out in 2007

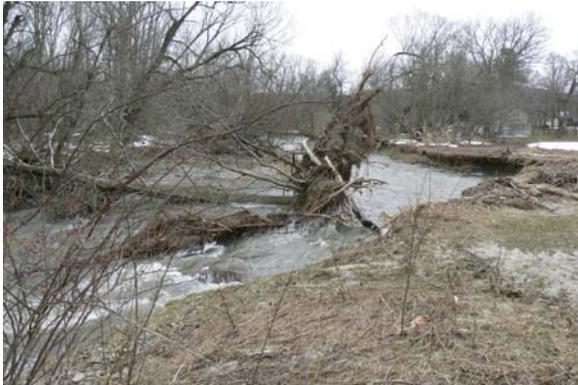
Trees and debris above bridge from March 16th runoff erosion

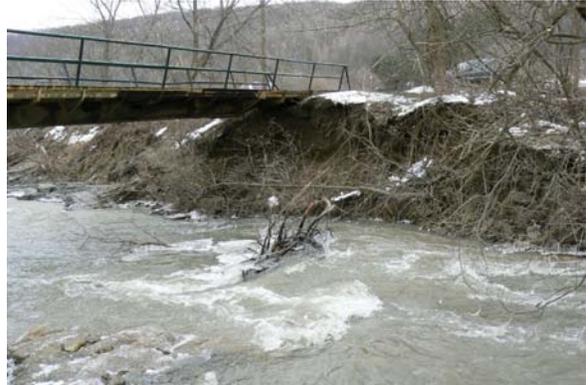
Landowner bridge being under cut from resulting head cutting by stream due to blow out of lower meander

The runoff event of March 16th changed all preliminary design plans. The stream channel was altered so much that the project landowner's bridge was in immediate danger of being completely under cut by the stream. This caused an immediate need to get emergency permits to protect the bridge and stabilize the stream until a new project could be completed to provide a more permanent solution. Under the emergency permit trees and debris were removed from the area above the bridge to prevent further damage. Rock was placed under the base of the bridge to protect from further under mining of the bridge. The stream was now stable enough to work on a design to stabilize the new concerns. The new concerns were the bypass of 1500' of stream channel causing a head cutting of 4-6' in many areas of the new stream channel. These concerns were highlighted by a 600' long vertical bank, which had been exposed by the runoff.

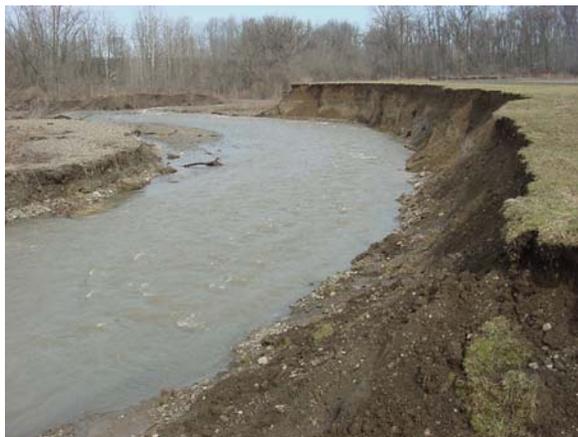
Deeply eroded 600' bank area below bank which gravel has been blow out by March 16th runoff bypassing 1500' meander

The first priority when the contractor started was to dig the diversion channel so most of the work would be completed in the dry. The construction of the new diversion channel provided much of the fill that was needed to grade the bank that the tree revetments would protect. To fill in the 600' long bank much of the old gravel deposits from past

runoff had to be used to get at least a 2:1 slope for proper stabilization. The removal of the gravel deposits help create a large floodplain, which will reduce concerns from future large runoff events. The construction of the diversion and grading the eroded bank took the first week of contractor time to complete.

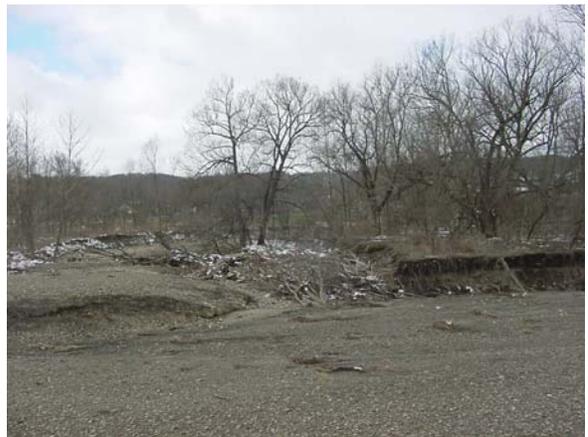
Blockage in stream which caused blow out on March 16th

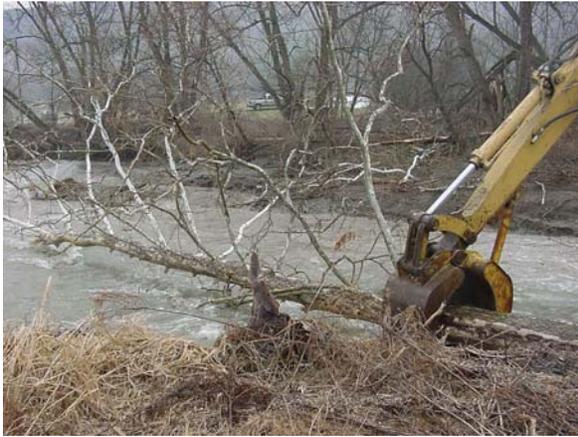
Moving tree out of stream and using it for temporary bank stabilization above the bridge

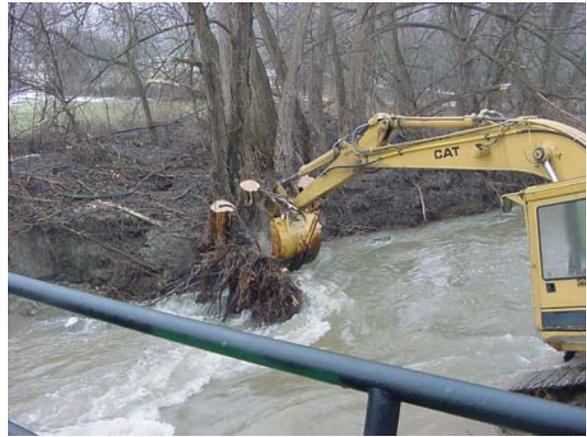
Using stump to key in rock to protect bridge

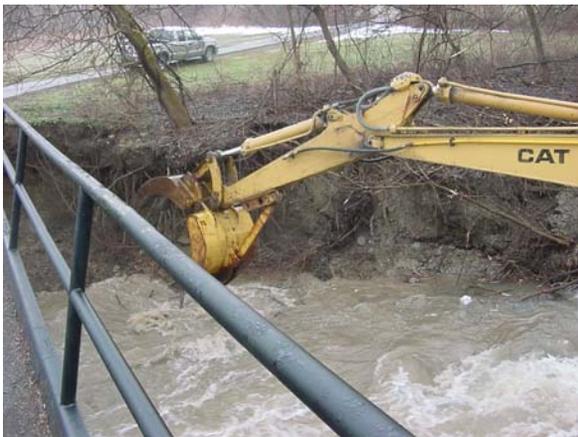
Placing rock to save bridge in high water under emergency permit authorization

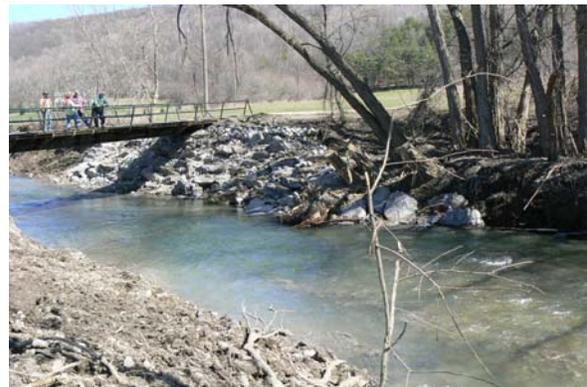
Completed rock protection under bridge April 2007

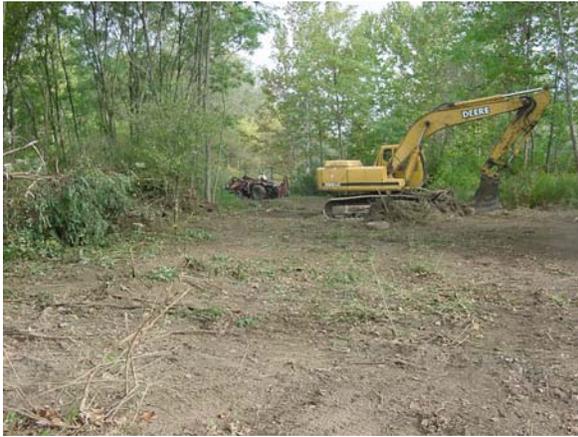
Landowner and contractor working to clear area for new diversion channel

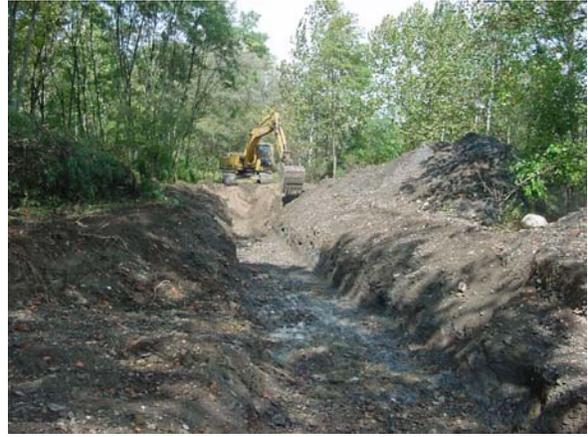
Digging new diversion channel to divert water during project and to be used as an overflow channel after completion

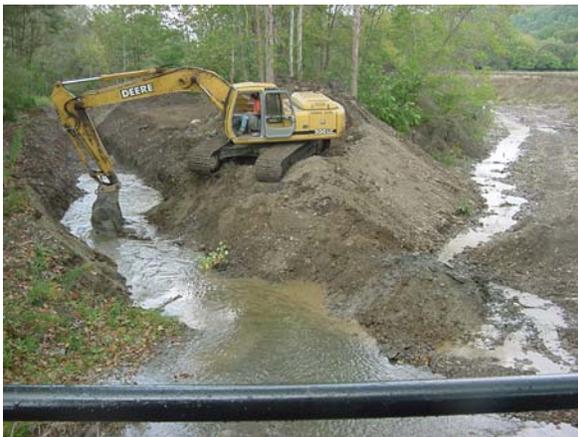
Moving stream flow to new diversion channel

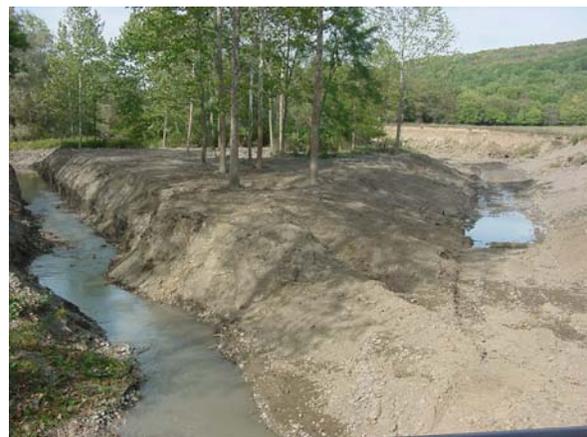
Water diverted from work area so construction of revetments and grade controls can begin.

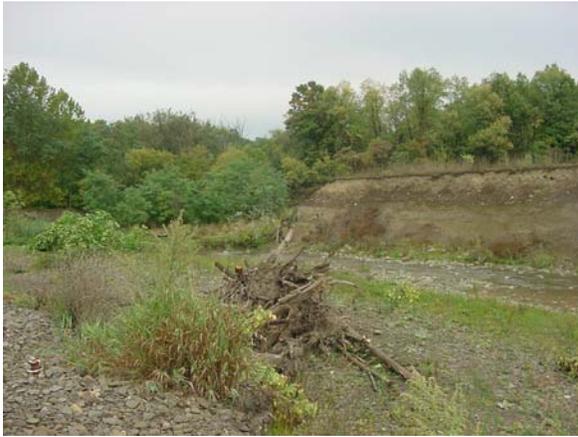
Stream is dry and debris and gravel to be placed on eroded bank

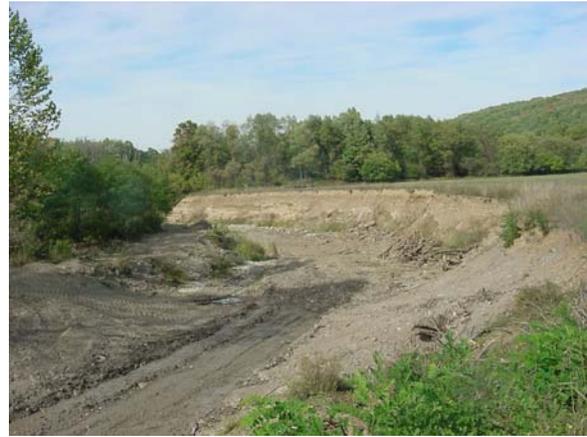
Starting to grade bank for revetments

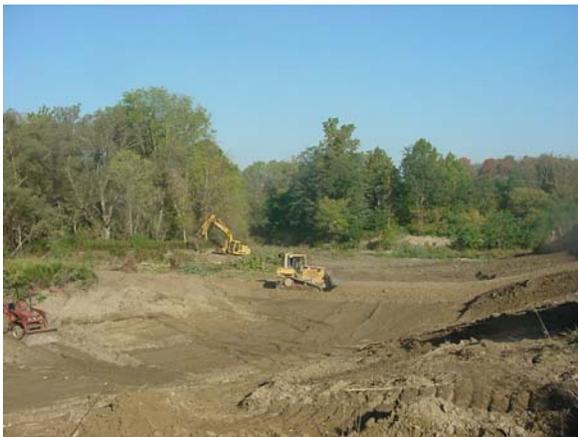
Material was used from past runoff deposits to protect eroded bank now that the stream channel had been diverted

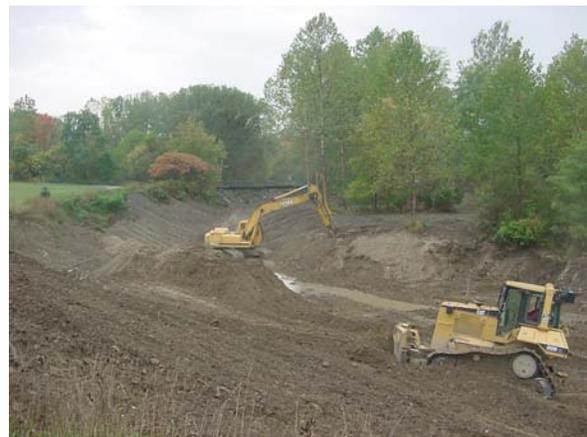
It took the contractor one week to install diversion and grade the eroded bank for the revetments with so much material to move

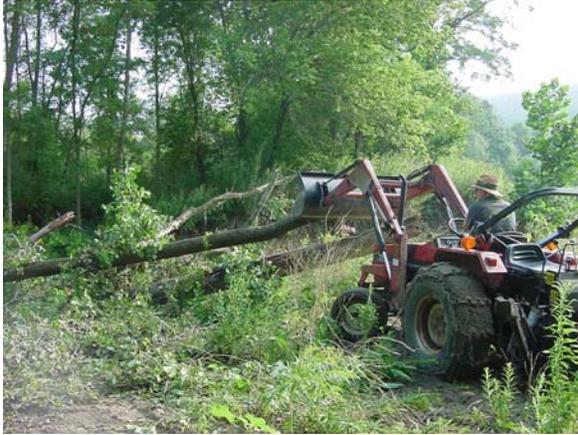
Landowner helps SWCD staff dragging logs and poles to be used with log revetments

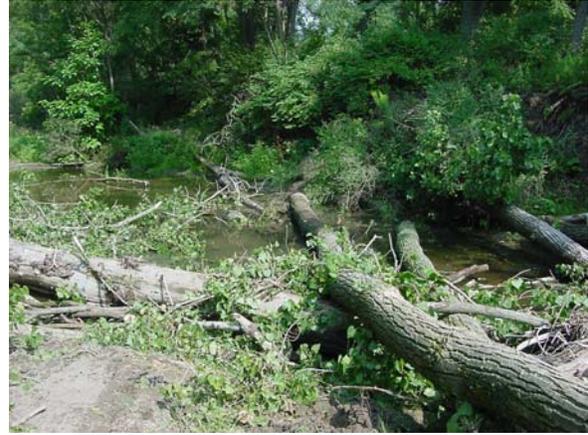
Logs and poles were soaked in small pond area in old channel to help stimulate sprouting

The project had a late start due to design changes, permit concerns and contractor scheduling. Work was finally begun in late August with the cutting trees for revetments and poles for plantings. The trees were cut and dragged down to be soaked in a small pond area of the old stream channel. There was over 1000' of old cable brought in that had been donated by a local landowner. Finally the large rock was ordered and delivered just before the contractor started.

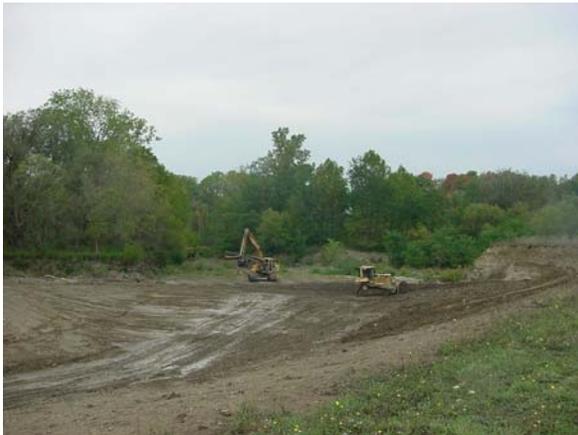
Contractor then moved logs up to a staging area for use as revetments

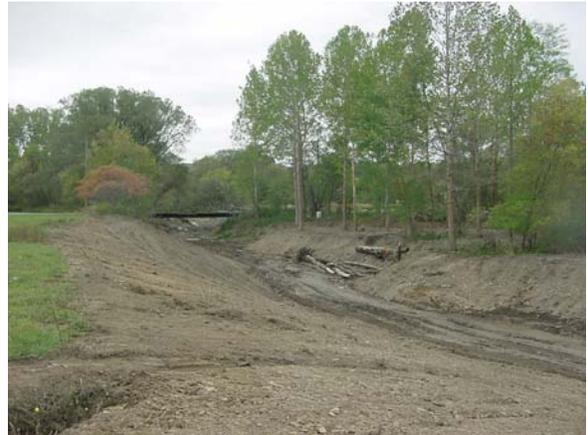
Logs are placed near bank to be installed as revetments

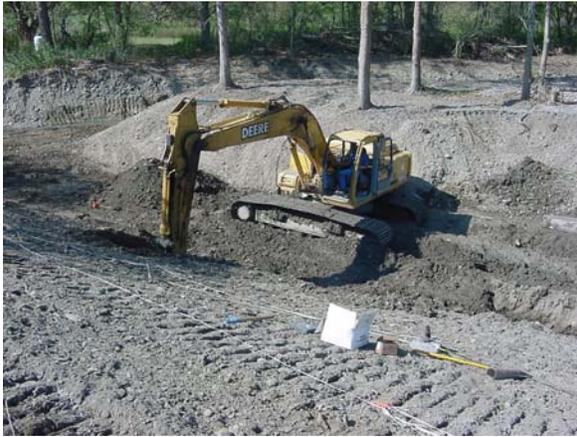
Trenches were dug at the base of the slope to install key logs into the bed of the stream.

The next step was placing the log revetments at the base of the slope of our newly completed bank. There was a key log laid into the bed of the stream as part of the DEC permit requirements. Then a second log was placed on top of the base log. Both of these logs were cabled together. These logs were also anchored to the bottom of the stream by a duckbill anchor and anchored into the slope of bank by a log dead man buried in the bank and cabled to the logs. The full 400' of revetments were constructed using the key logs with both dead men and duckbill anchors. At the beginning and middle of the revetments log grade control structures were placed to maintain the stream level and prevent undercutting of revetments. The log grade at the front of the revetments was 40'+ Sycamore tree with a 7' diameter root ball that buried in the stream bank and large rock was used to anchor the other end along with duckbill anchors. The log grade control in the middle was a large Cottonwood log that was tied into the revetments on one side and buried with stumps to protect the downstream as well as duckbill anchors. During construction concerns were raised about the amount of runoff coming down the slope in the middle of the revetments. There was concern that this concentrated flow would erode our bank behind the revetments. To address this issue a rock basin was constructed at the top of the slope and erosion blankets were stapled to the slope below the rock basin to reduce erosion concerns. The final part of the log revetments was to place gabion stone behind the

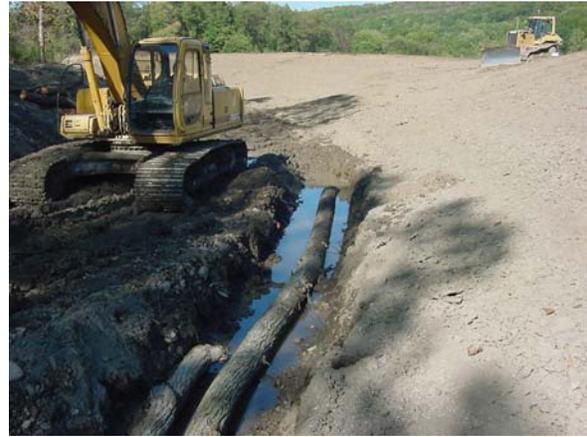
Key logs were placed in trenches and then logs were placed and cabled to the top of them

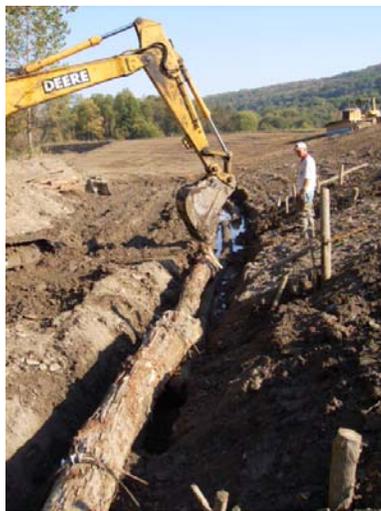
Logs were placed on top of key logs and cabled to the key log

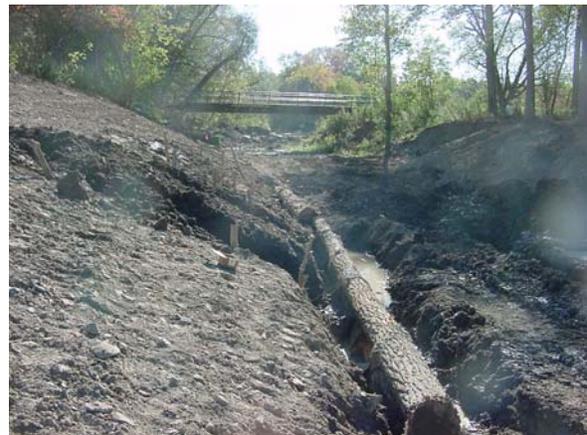
Logs after being placed together and logs were secured both with a duckbill anchor and a deadman in the bank

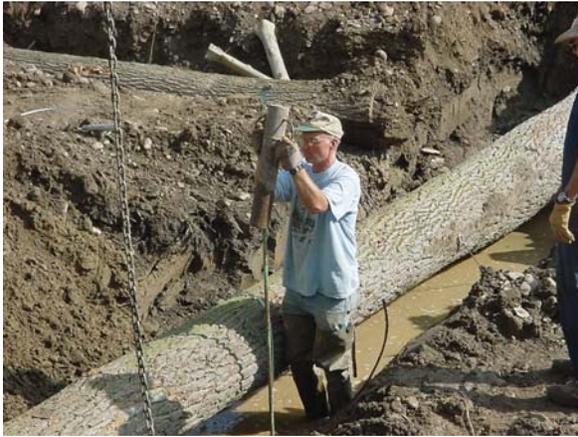
The duckbill anchor was driven into the streambed

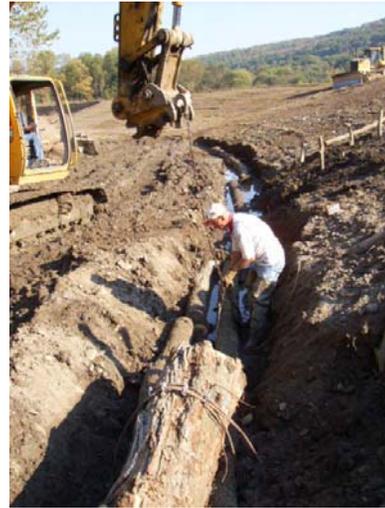
The anchor was then chained to the excavated arm

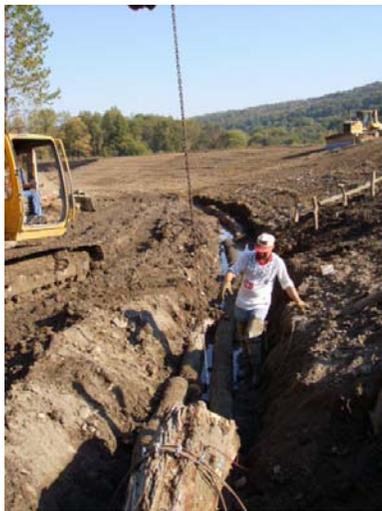
The excavator pulled and set the anchor in the stream to hold the key log down

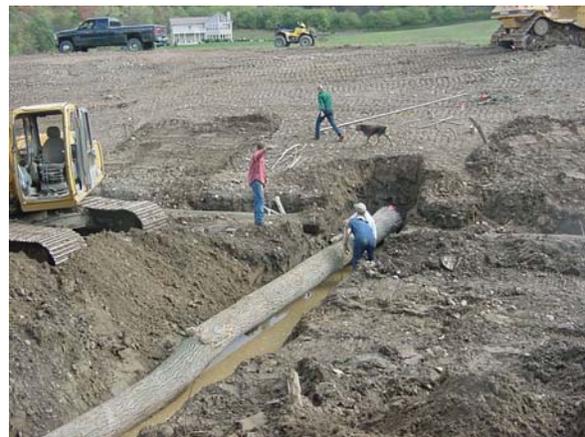
Then the cable of the duckbill anchor was cabled around the logs to hold them in place

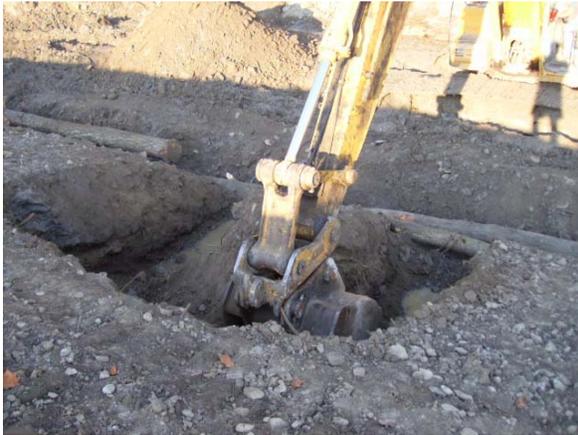
Holes were dug into the bank to place deadmen logs to hold in revetments

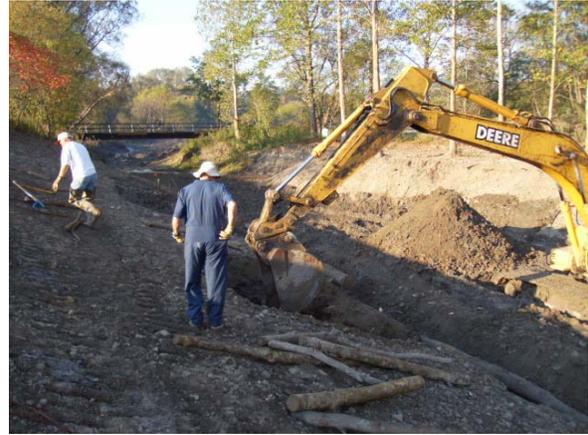
Logs were placed into the hole by the excavator

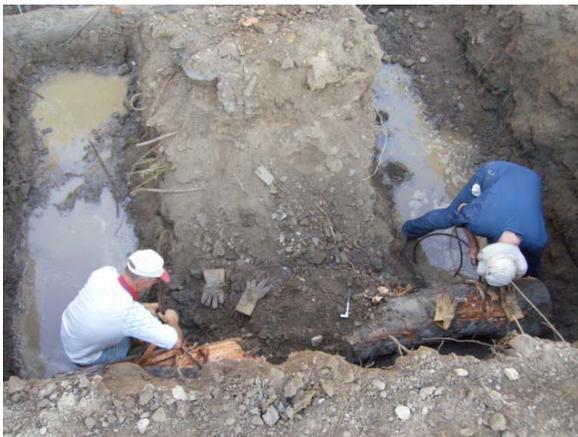
Cables were attached to the logs and later attached to the revetments to hold them in place

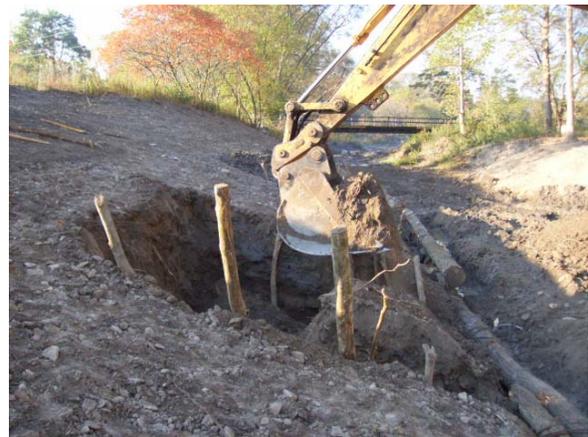
The logs were buried with poles placed into the side of the hole which will

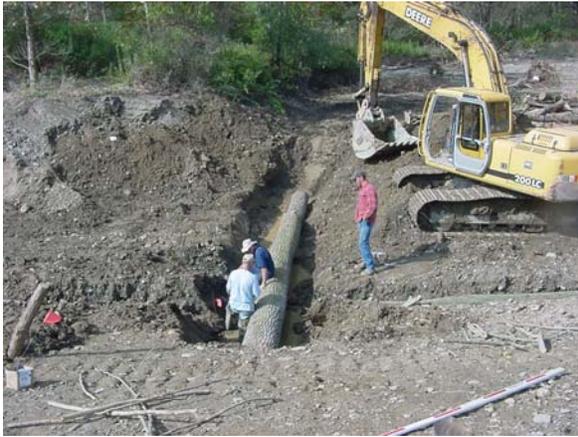
A large log was used as a grade control at the midpoint in the log revetments

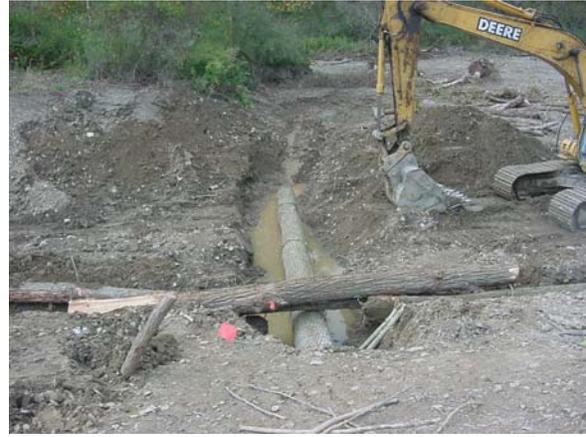
The log was anchored in with the duck-bills and revetment logs were cabled on top to hold it in place

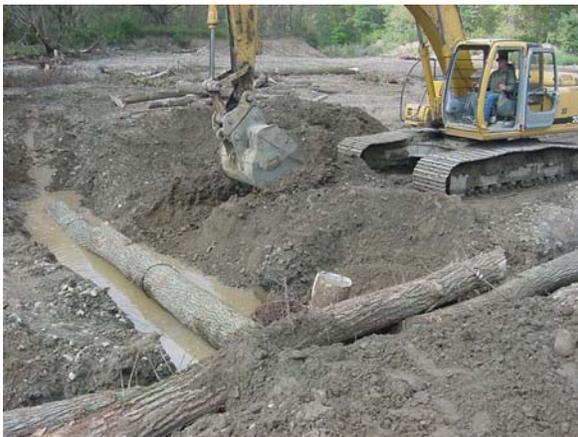
Stumps were placed of the downstream side to further anchor the log and have sprouts come from the stumps

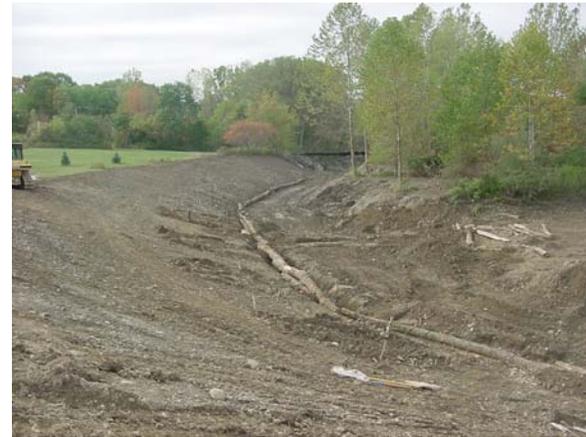
View of revetments anchored in place ready for rock to protect from scour

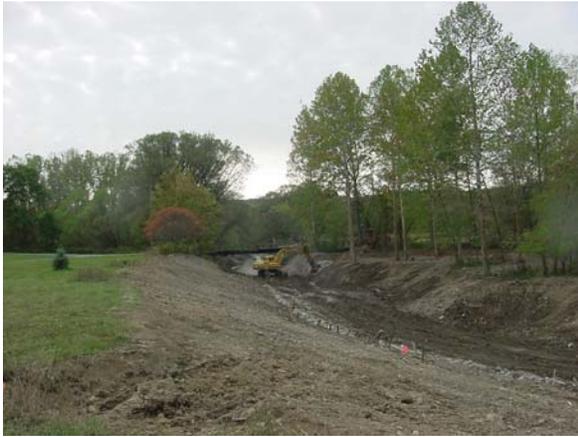
Rock was placed by excavator and hand behind revetments to protect newly graded slope

logs to prevent high flows from eroded the new soil from behind the logs.

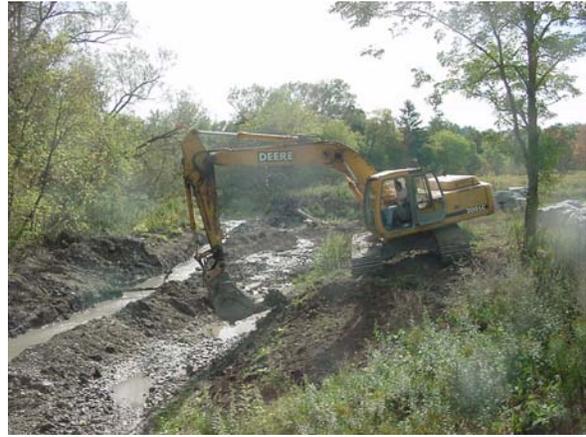
Preparing slope for rock protection above bridge

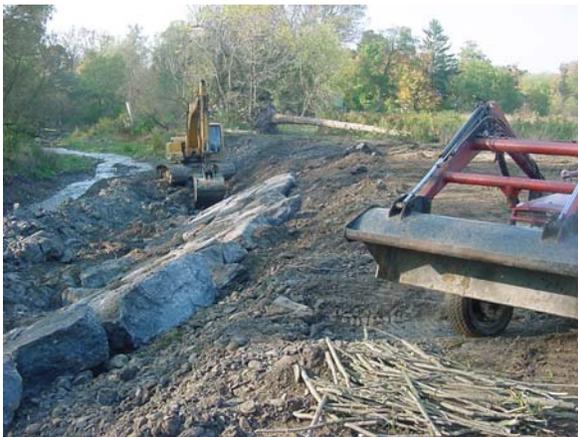
Placing slope rock and placing planting between rock as required by permit

After completion of the revetments the rock work was completed above the bridge. First a 55' rock key was buried into the stream bank to prevent the stream from bypassing the bridge to the west. There was a 130' slope rock protection completed below that key. There was similar rock key placed on the east side of the stream and keyed into to the large willows on the bank and the rock placed under the bridge in the spring. Then a compression rock grade control was installed from the key toward the bridge. The rock grade control was installed to prevent any further down cutting near the bridge and protect the landowners telephone and gas line buried upstream of the structure.

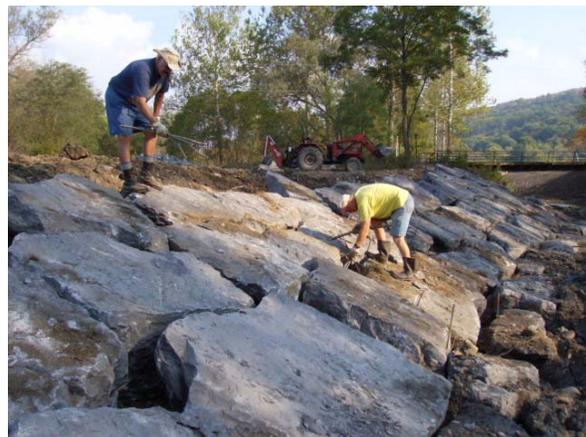
Placing plantings on completed slope rock

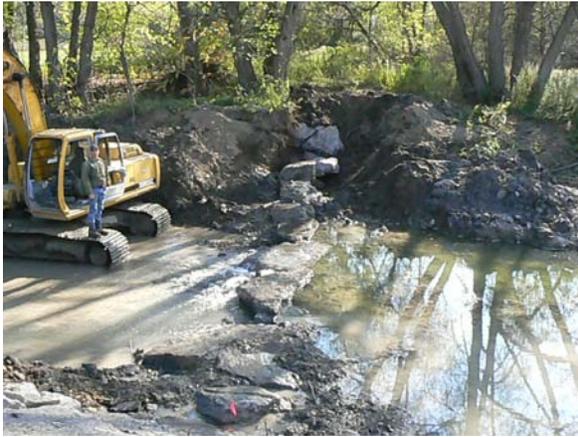
Starting rock gradecontrol at end of slope rock and keyed into bank on east side of stream

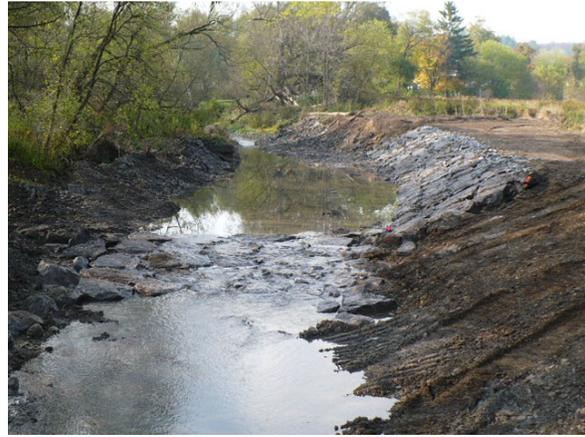
Rock grade completed and end of slope rock

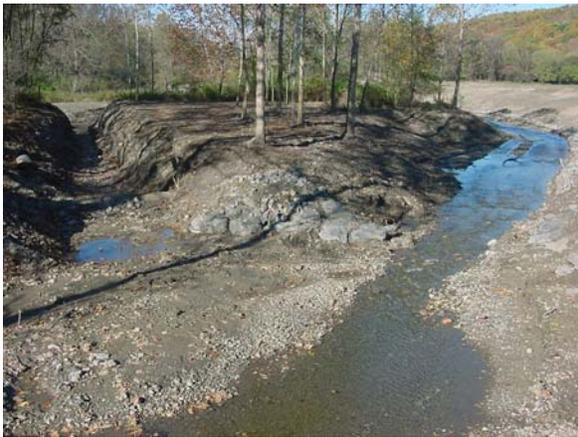
Overflow diversion and new channel after complete

The last part of the project was to protect the bank from the rock under the bridge to the start of the new log revetments with large toe rock. Then the stream was diverted back into the old channel and a log grade control was placed into the new diversion channel. This log grade control was set to allow all base flow down along the new revetments. This grade control was set so when the stream becomes high enough it will flow down the diversion and take much of the pressure off the revetments. The goal of this will be to protect the revetments from being damaged during high flow events. The last part of the project was to seed all disturbed areas to reduce erosion.

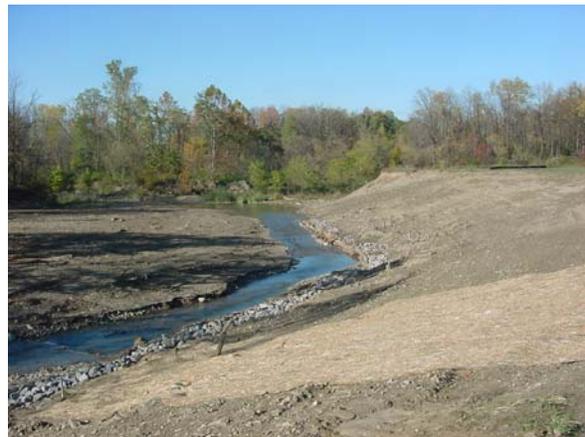
Lower section complete at end of re-vegetations
