Town of Castile

Road Ditch Stabilization Project

Luther Grove Road - Silver Lake

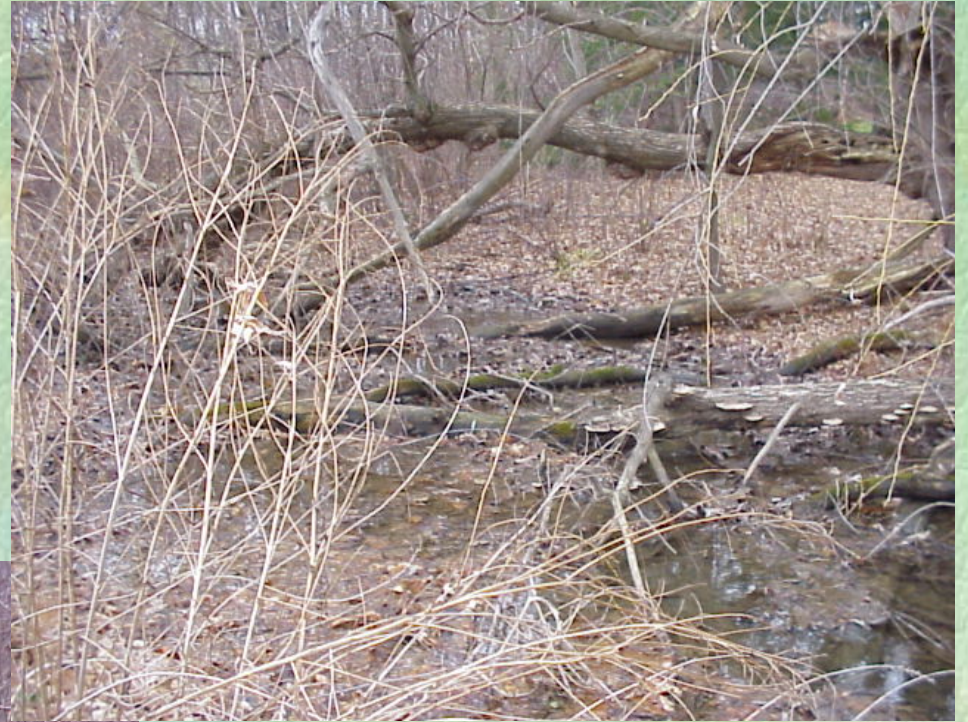
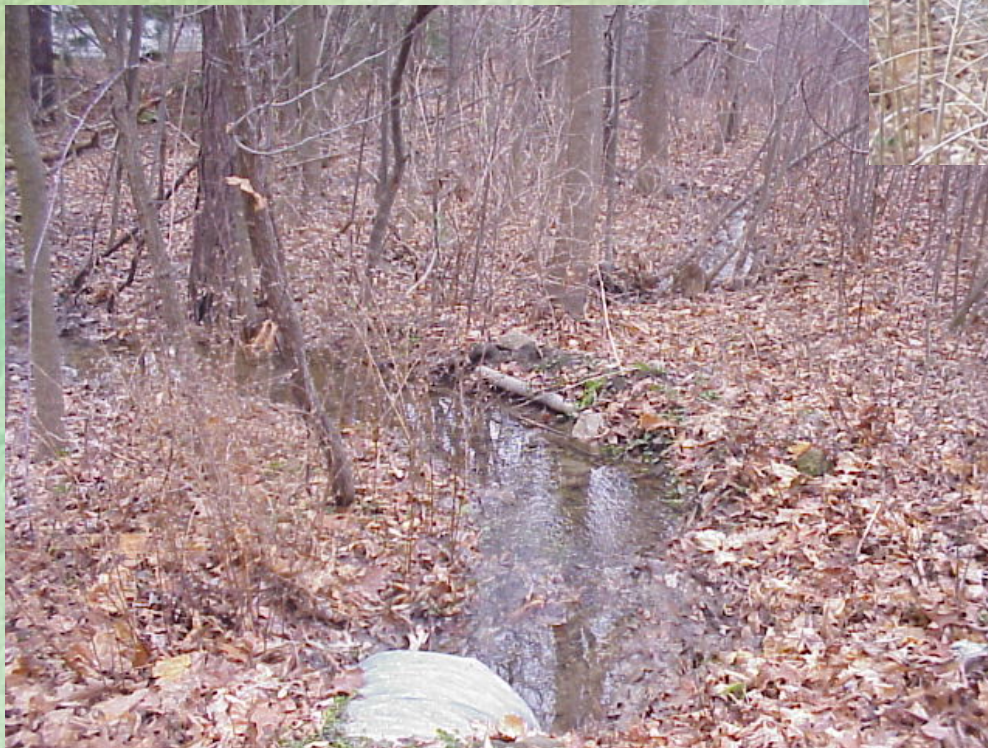
The outlet channel on the Serventi Property was overgrown with several fallen trees blocking channel flow.

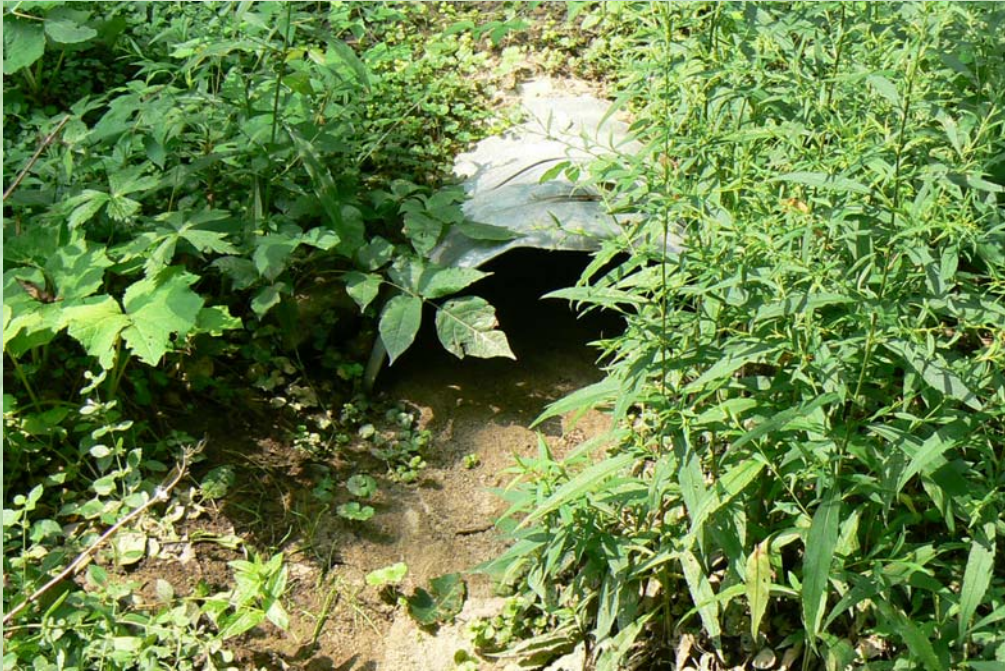
**Plugged 24" CMP
Culvert Pipe at Outlet
end of Ditch.**

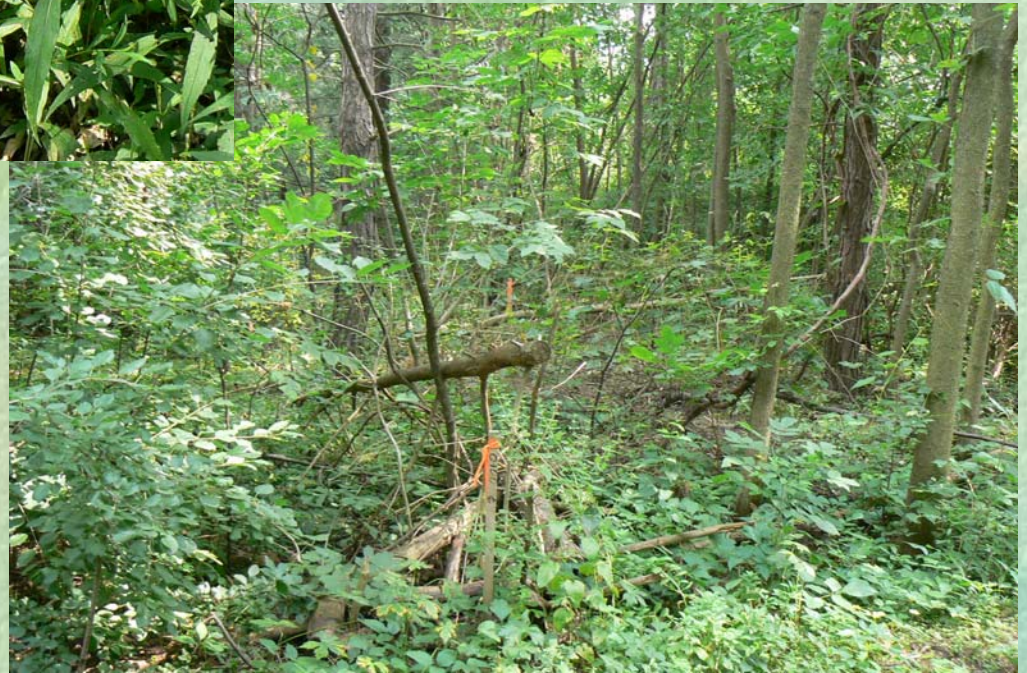
New outlet channel as staked out.

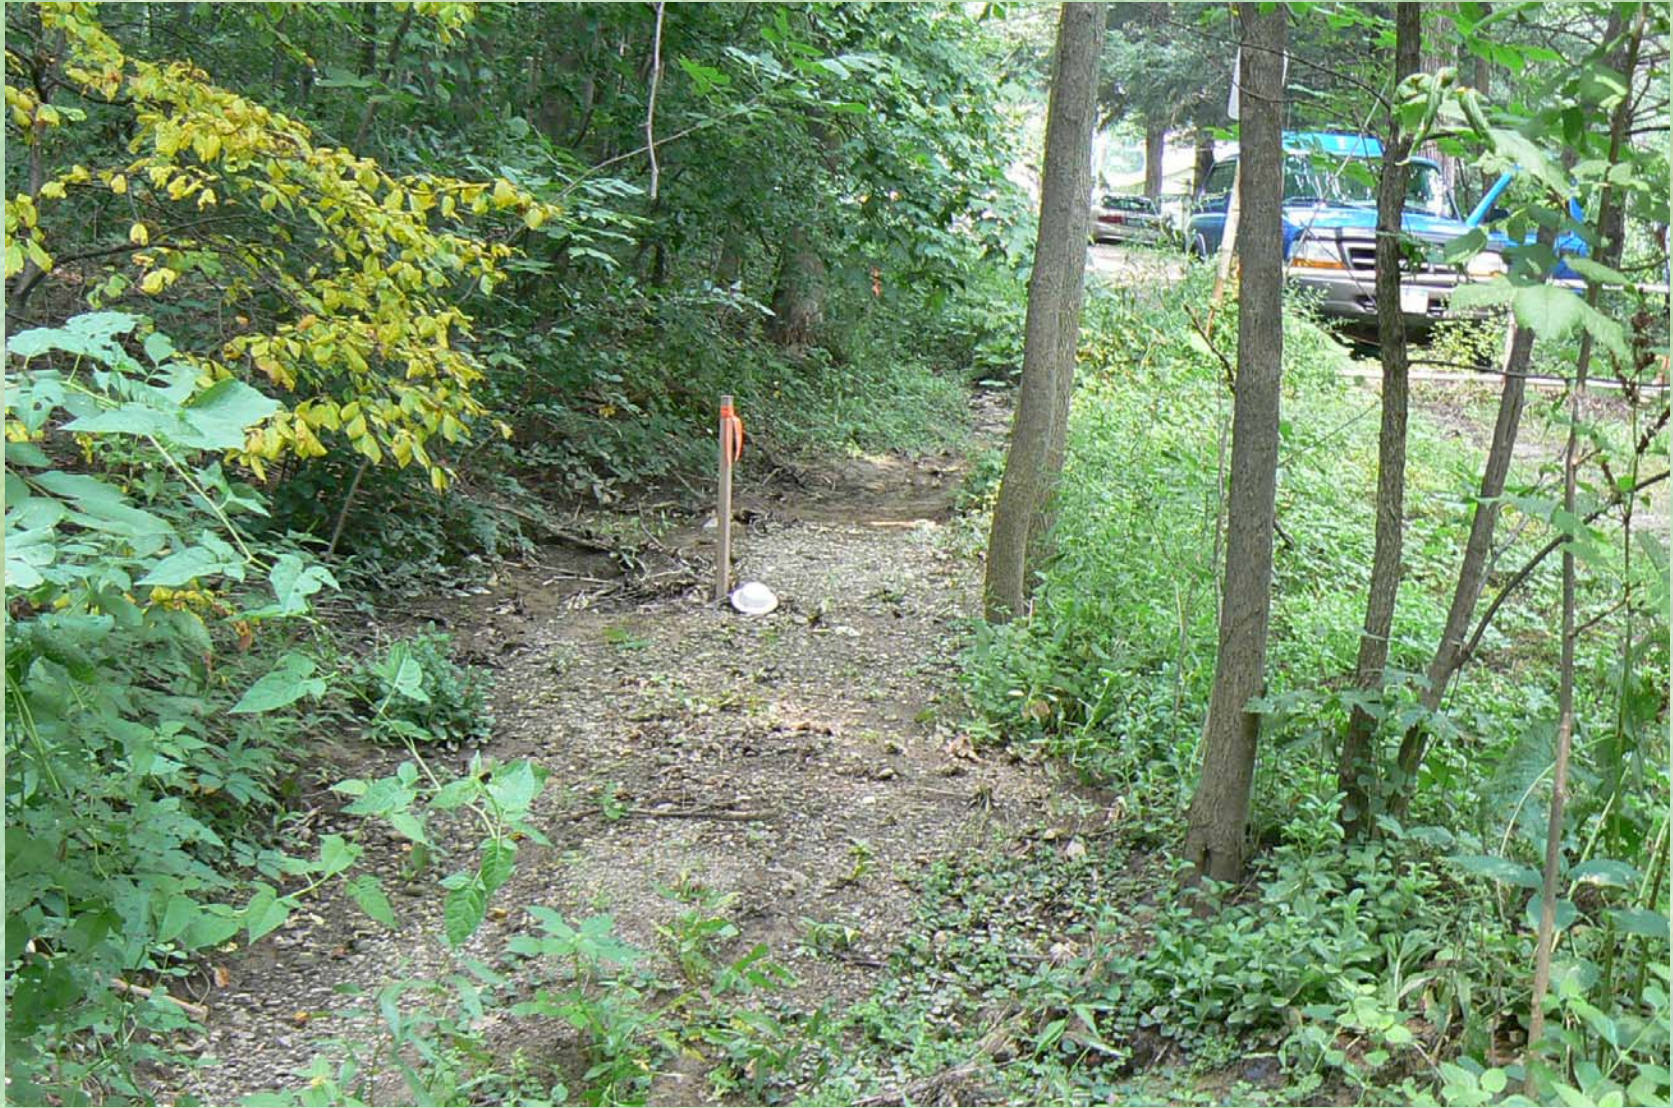
Sediment deposits impede channel flows and cause localized flooding.

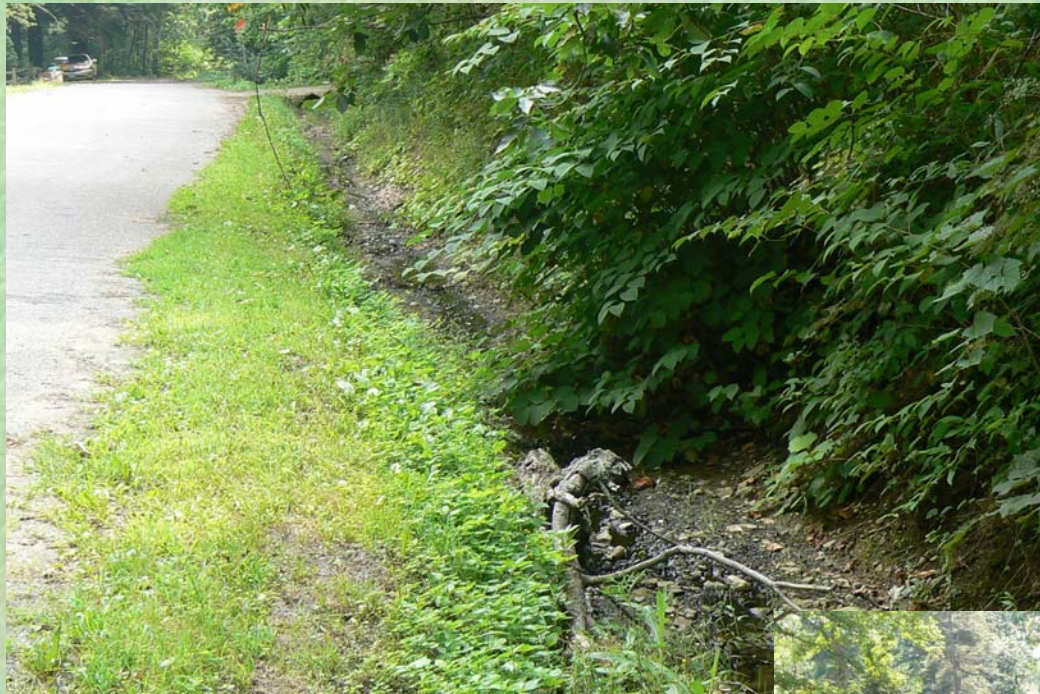
**Road ditch following
tree trimming and
sediment removal.**

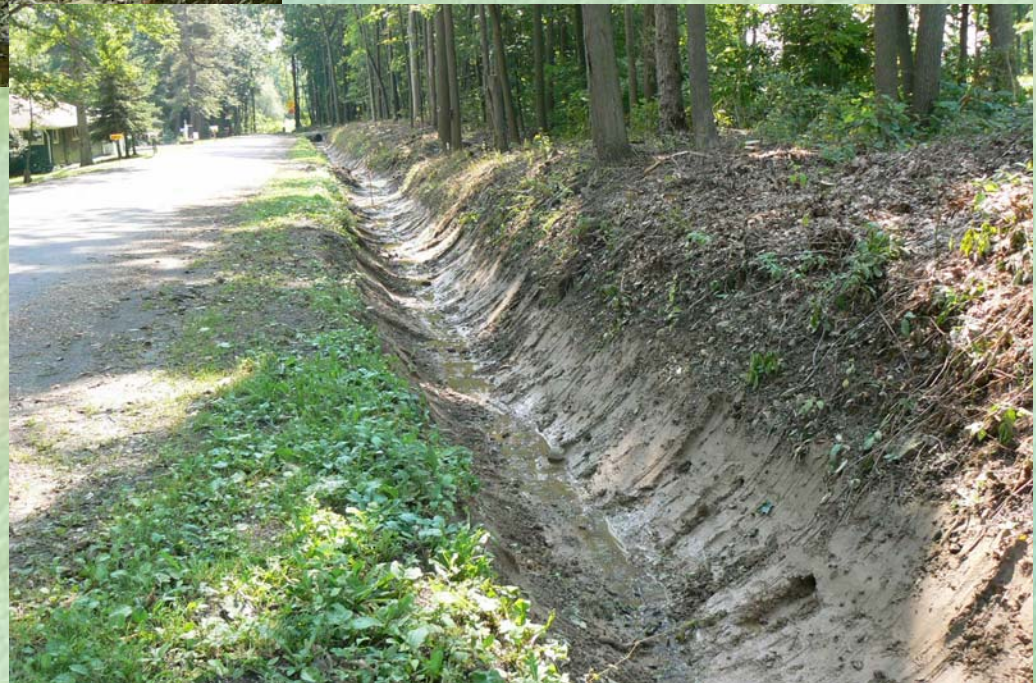
**Road ditch in
before conditions**

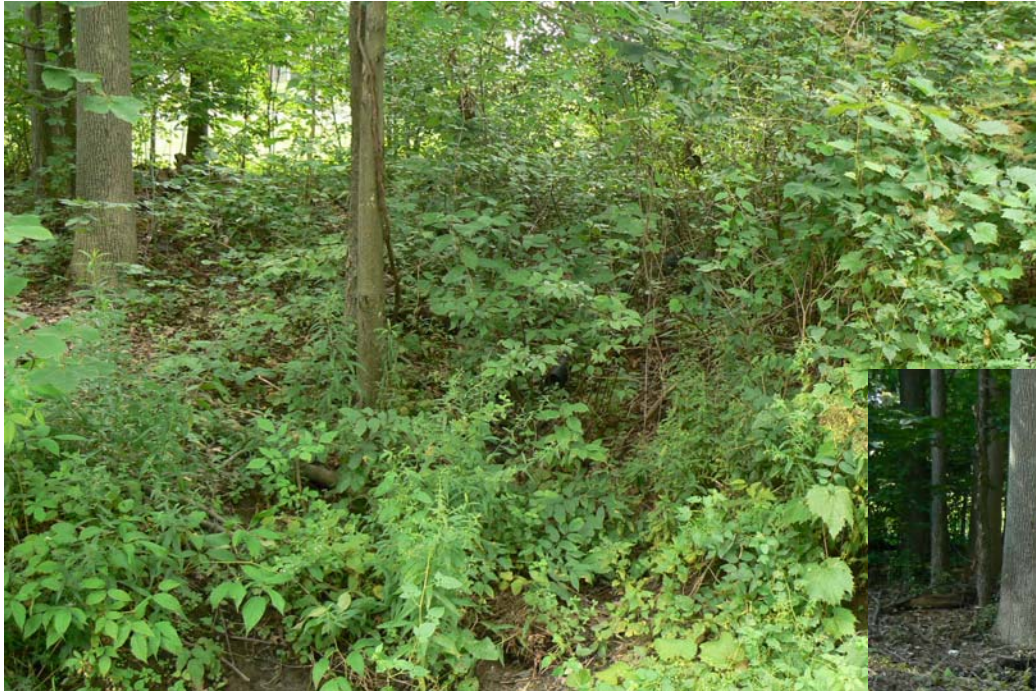
**Existing side drainage
from golf course**

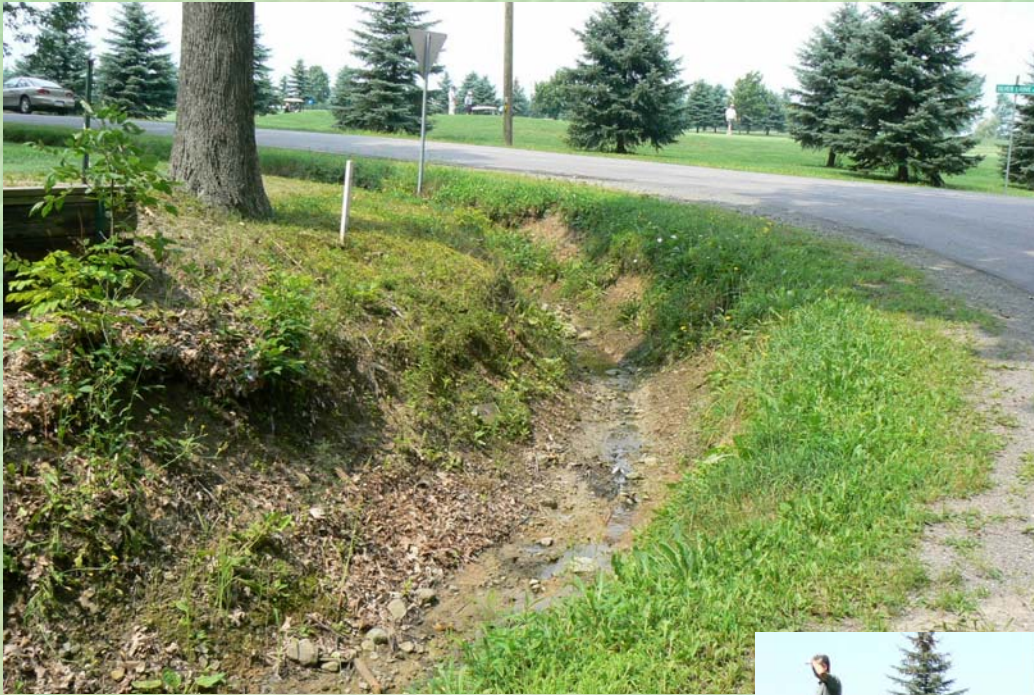
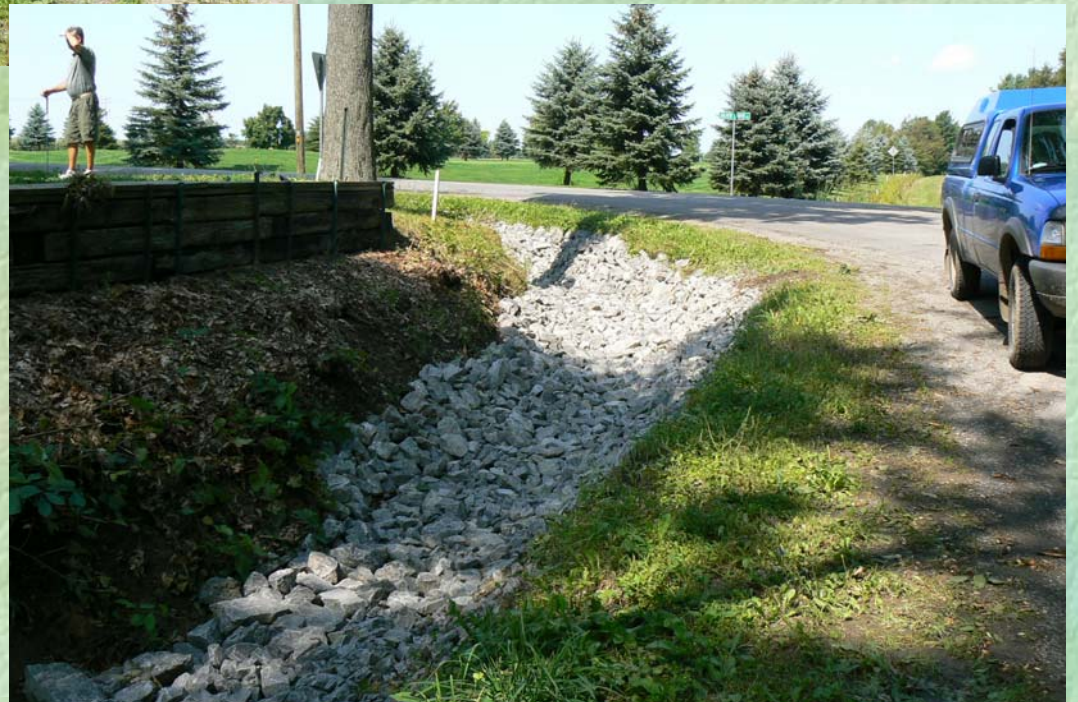
**Rock lined channel at
corner of Silver Grove &
Luther Grove Roads to
reduce ditch erosion -
Before & After.**

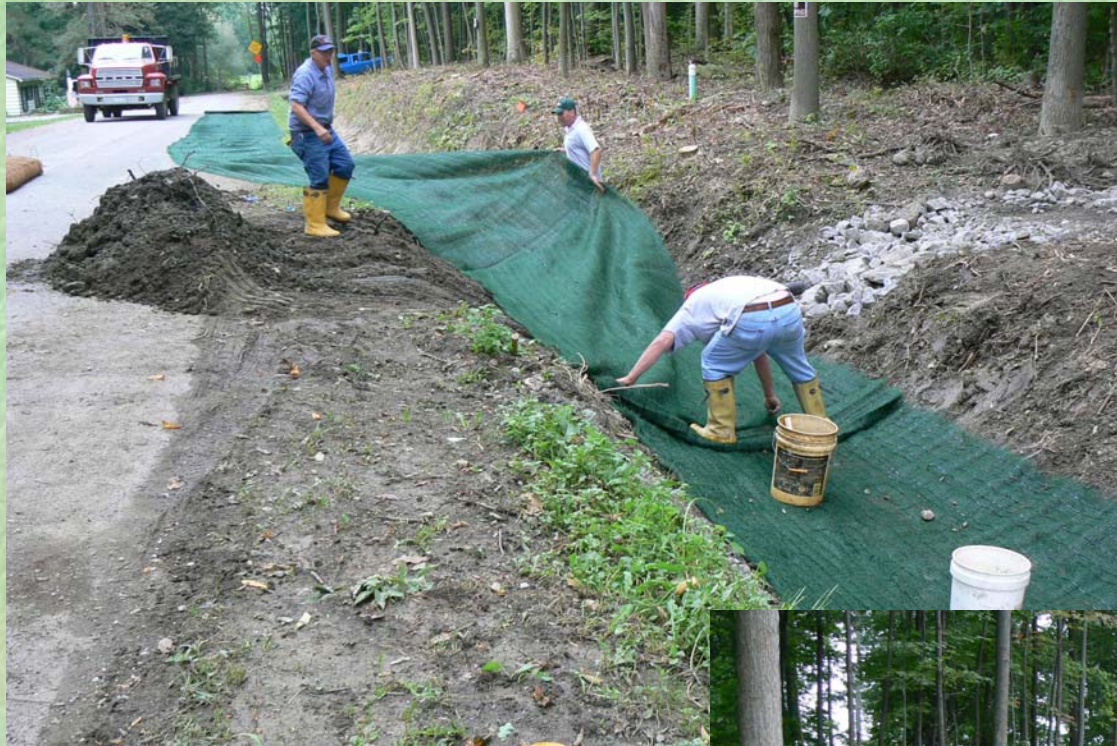
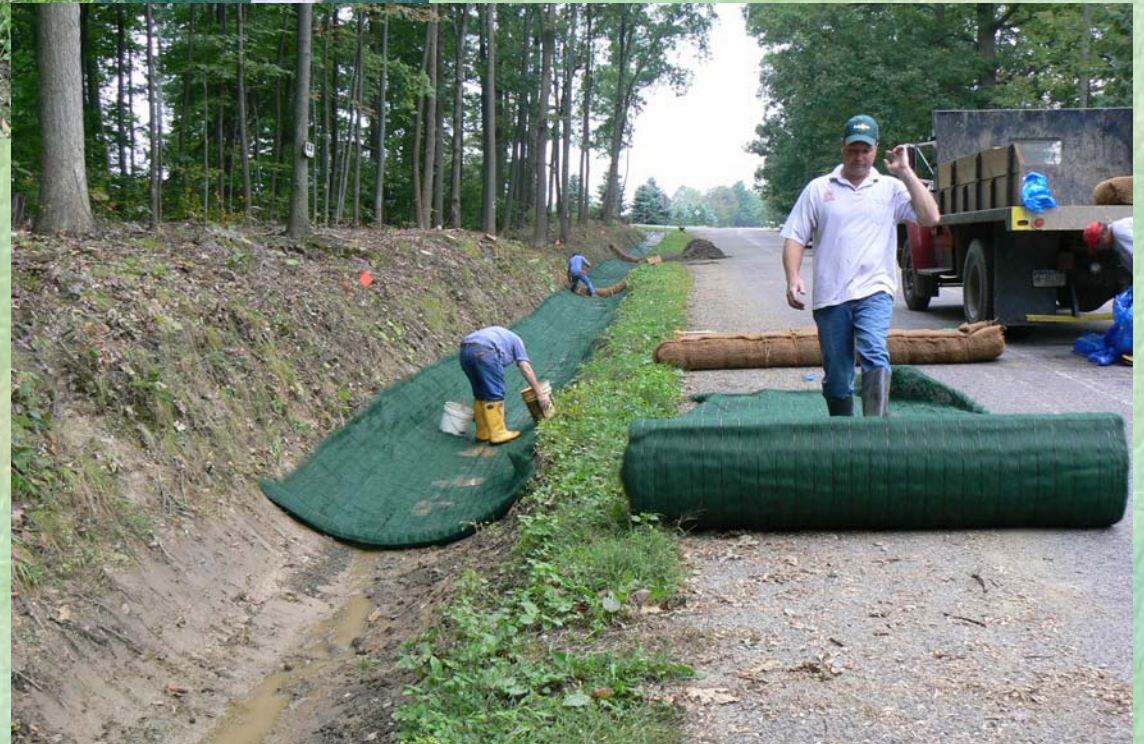
**Town of Castile Highway Dept.
& Soil & Water Conservation
District Personnel installing
Land Lok 450 Permanent
Reinforcement turf along
center of road ditch.**

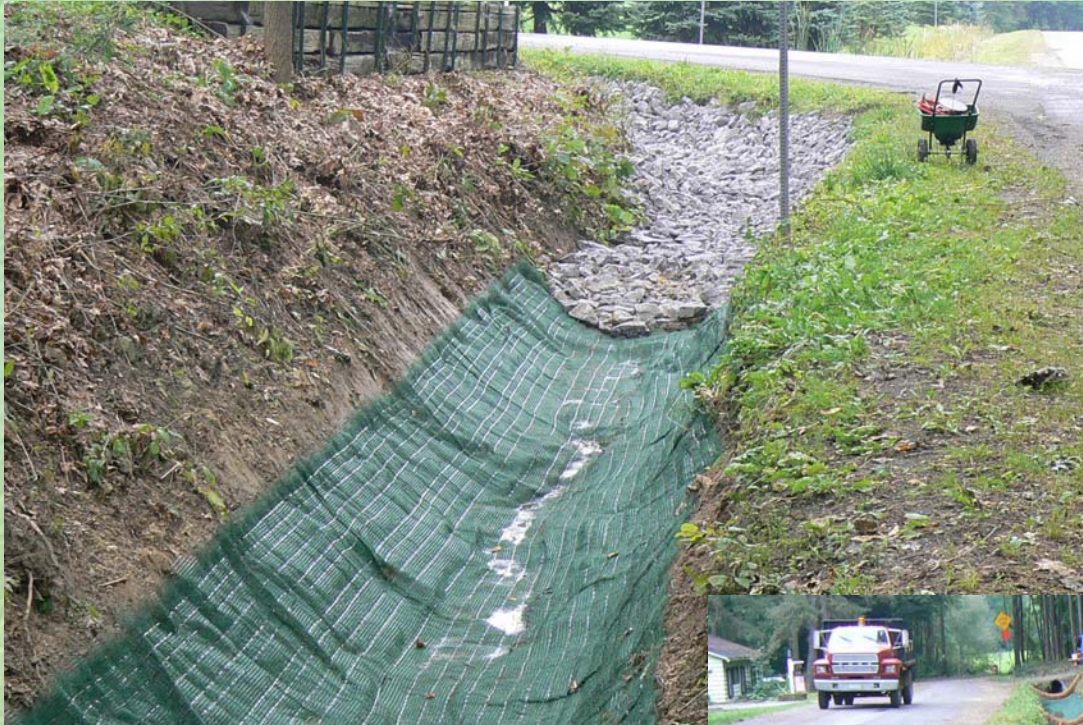
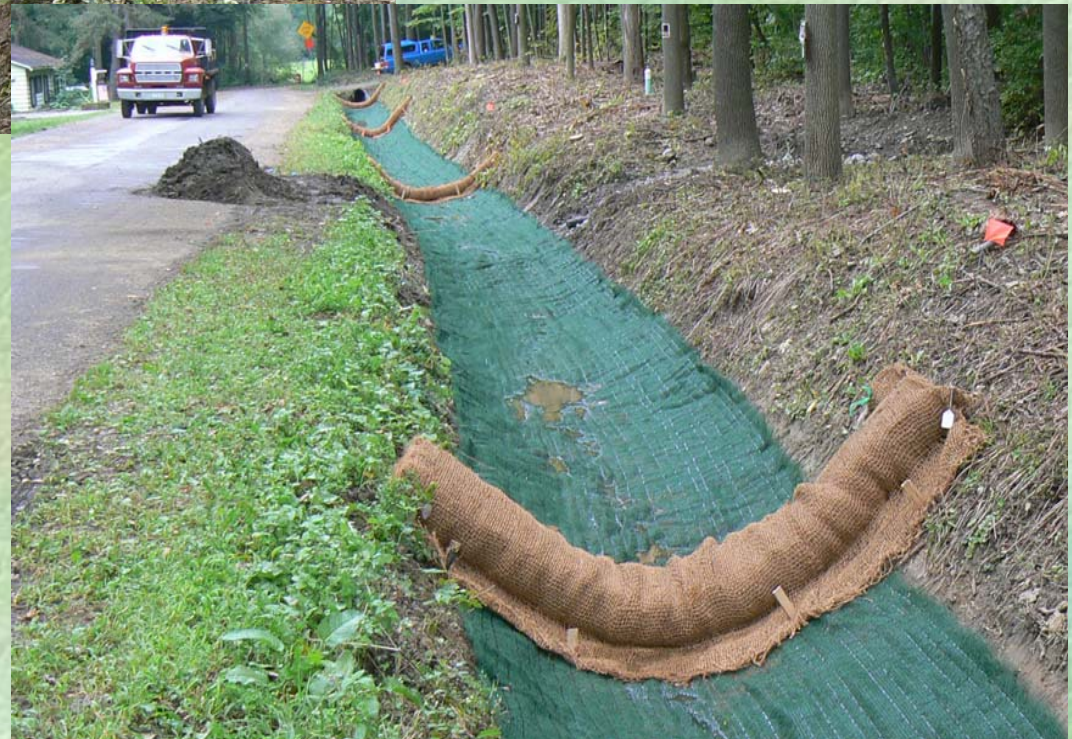
**Reinforcement turf
with rock and coir
log check dams.**

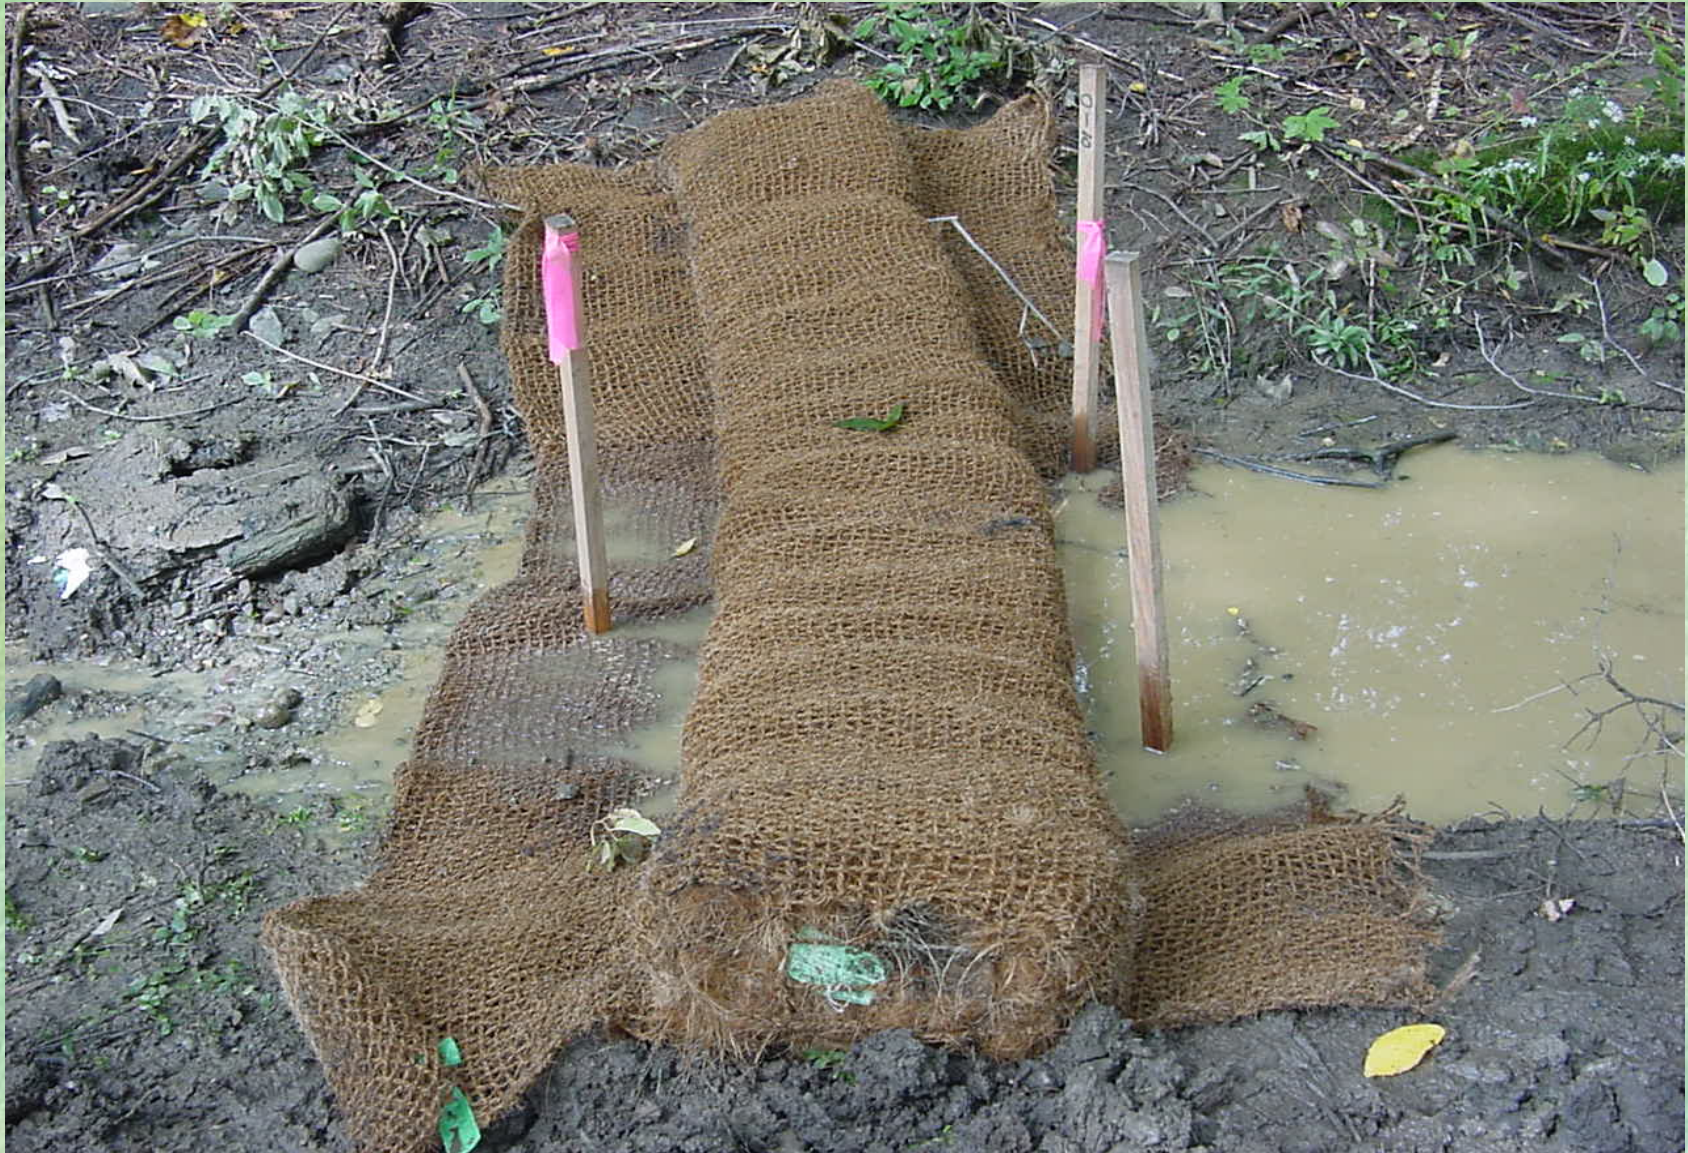
Coconut Fiber Coir Logs Installed as Permanent Check Dams

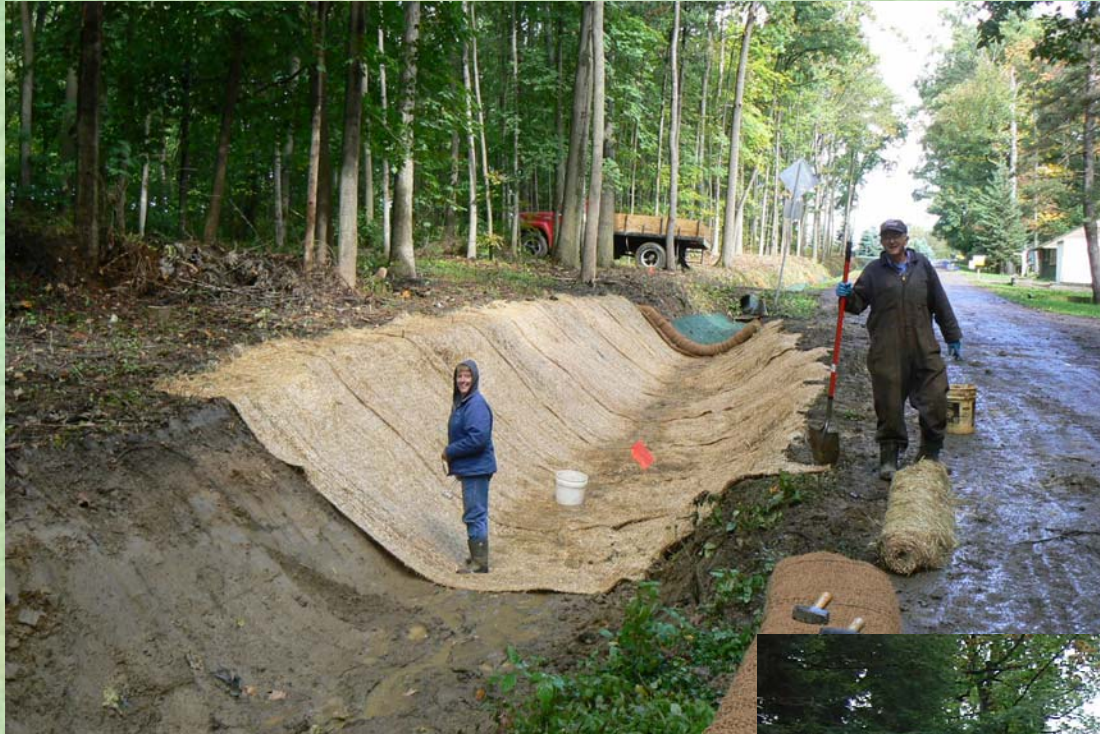
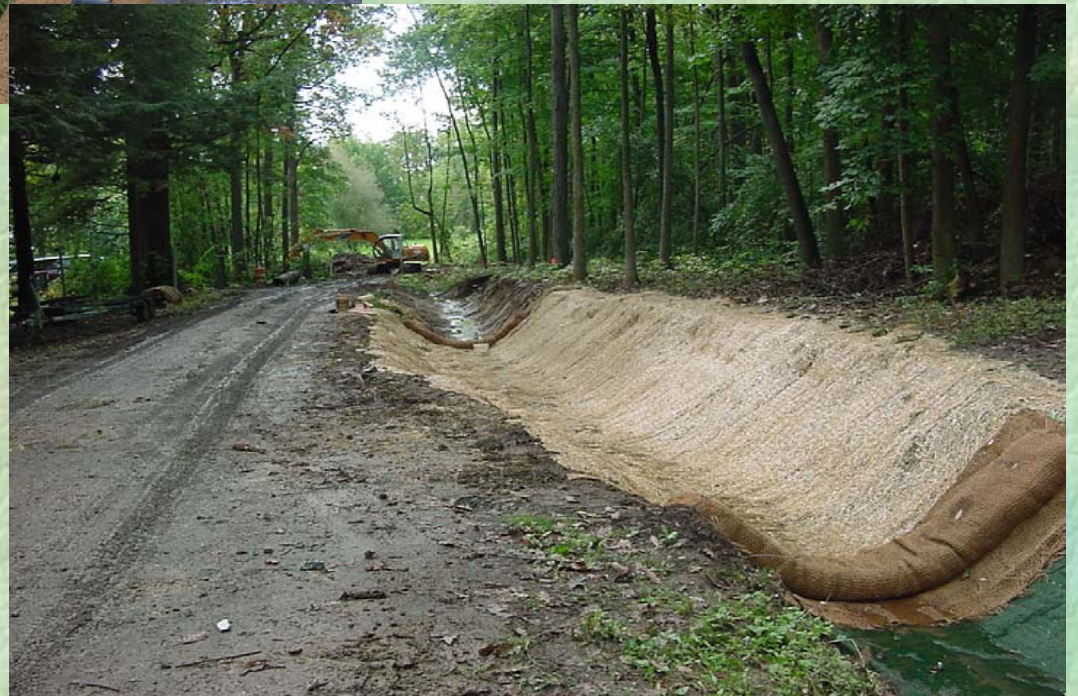
**Town of Castile Highway
Dept. & Soil & Water
Conservation District
Personnel installing Land
Lok CS2 coconut/straw
erosion control blankets
along center of road ditch.**

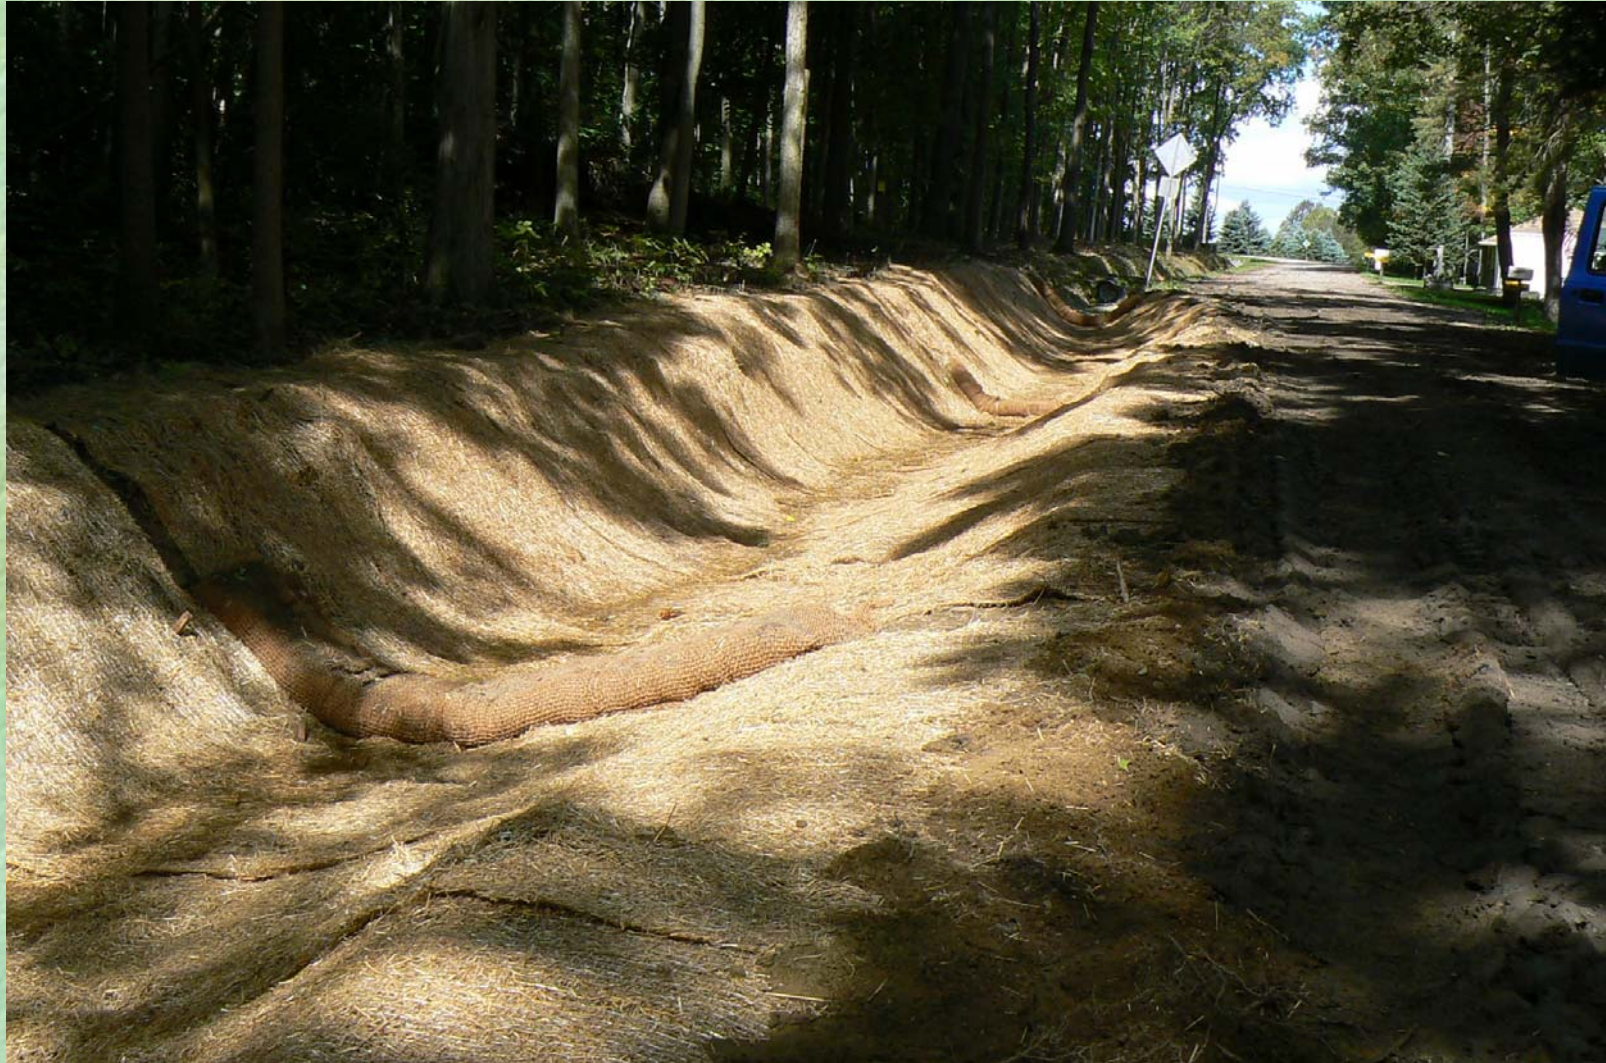
Completed channel stabilization at Luther Grove Road.

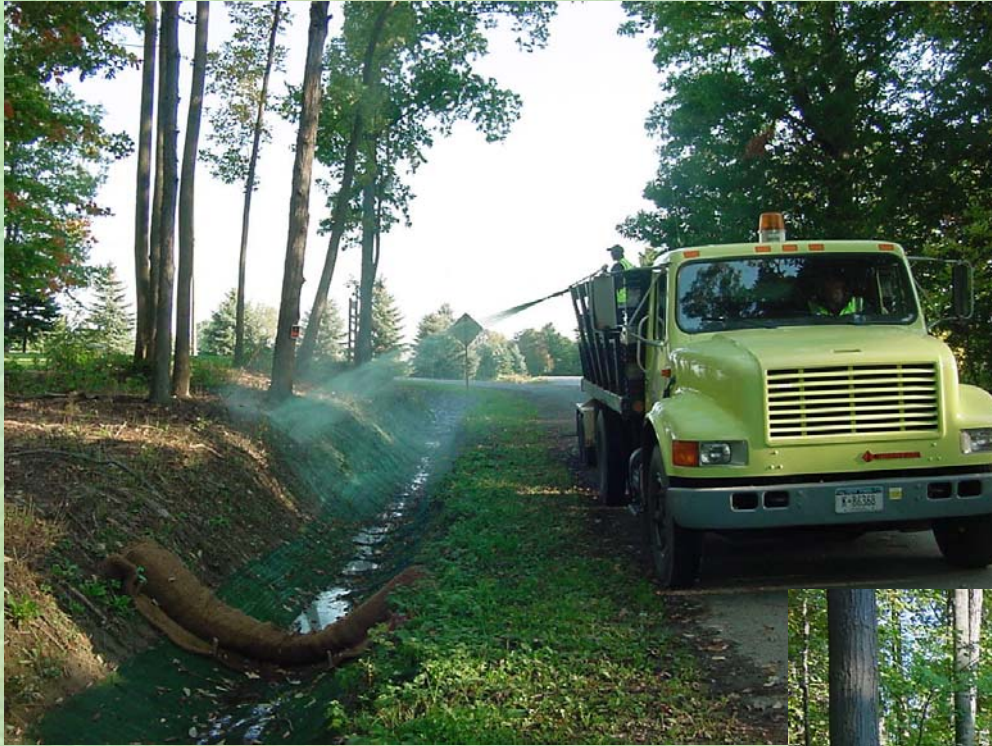
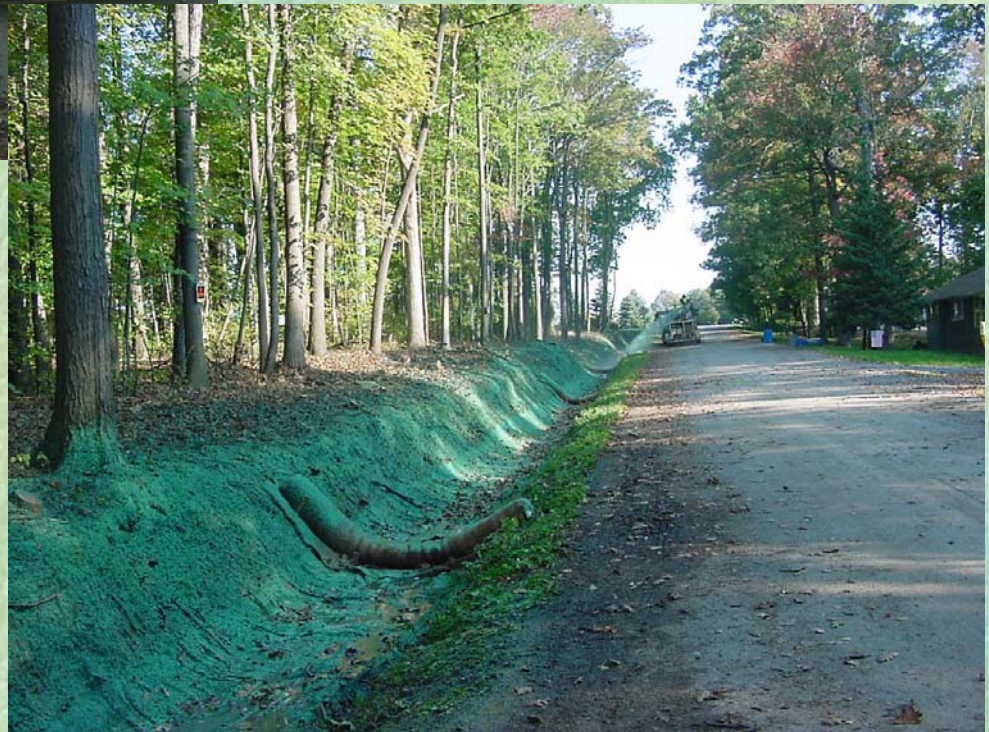
**Hydroseeding
completed
by the Wyoming
County
Highway Dept.**

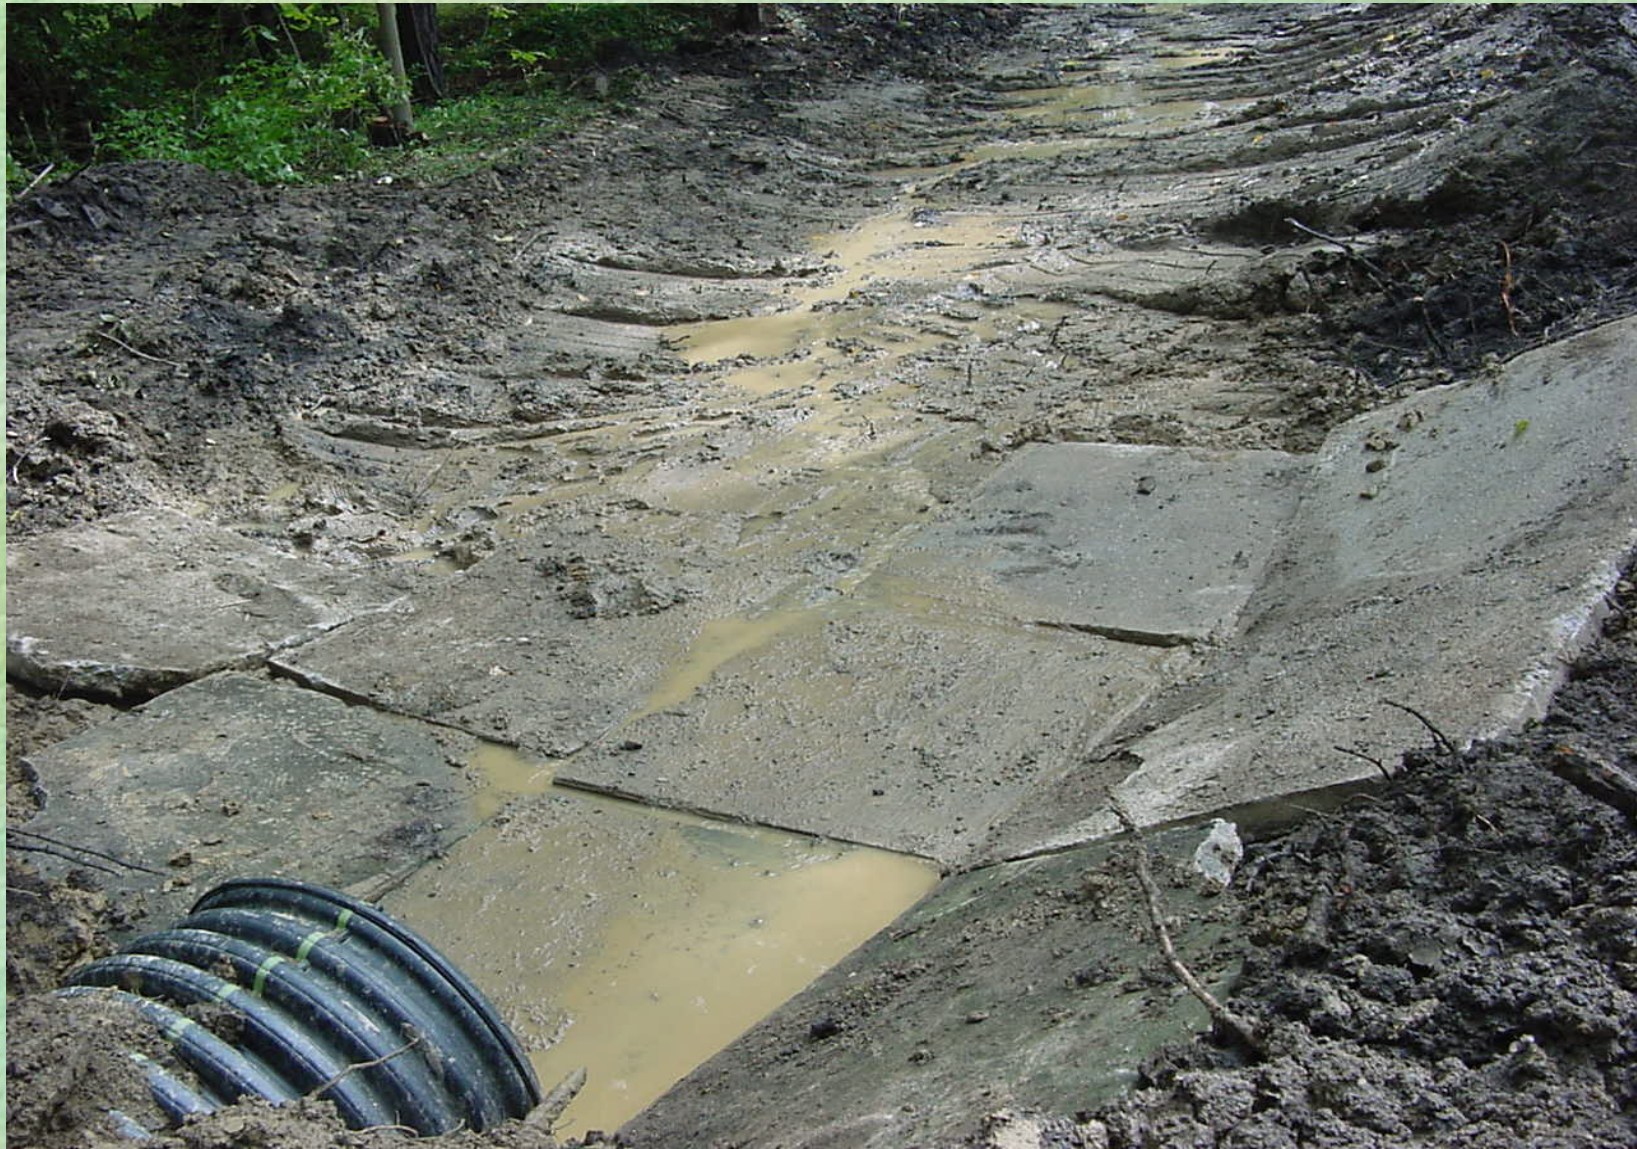
New 30'' plastic culvert pipe with outlet protection.
