Wyoming County Fairgrounds Streambank Restoration Project

April 7, 2005 - August 9, 2006

Wyoming County Soil & Water Conservation District

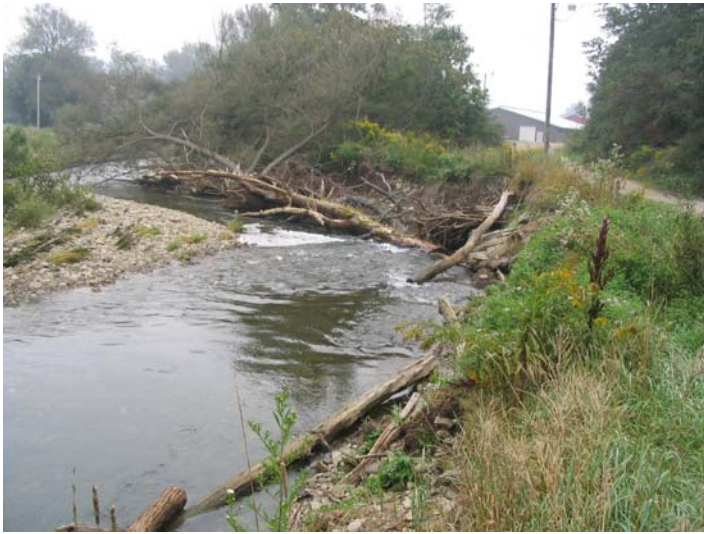
Looking downstream, you can see that the right bank is nearly vertical as a result of severe erosion.

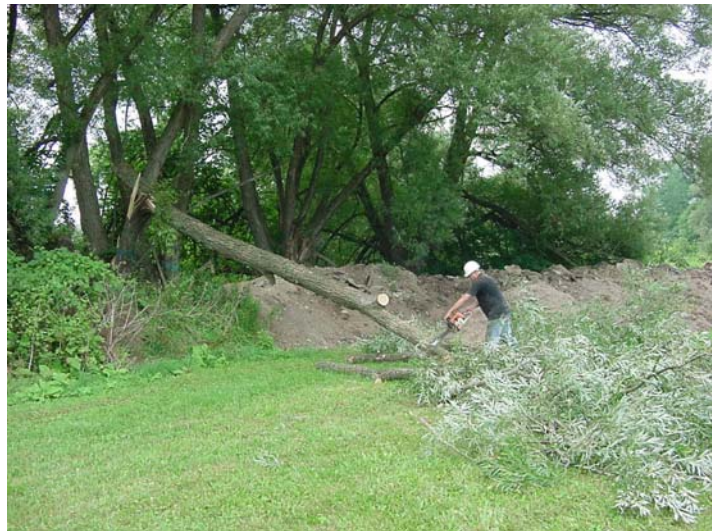
Trunks from nearby trees were cut to serve as new revetments.

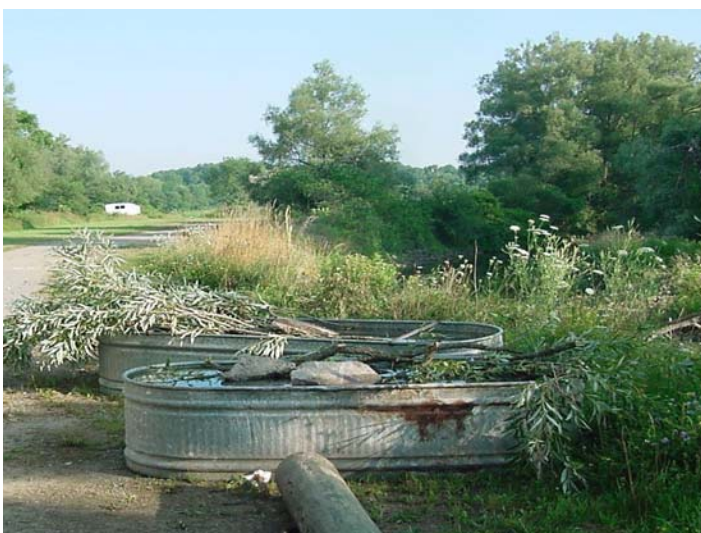
Smaller branches were cut and soaked to promote root growth and sustain viability until planted.

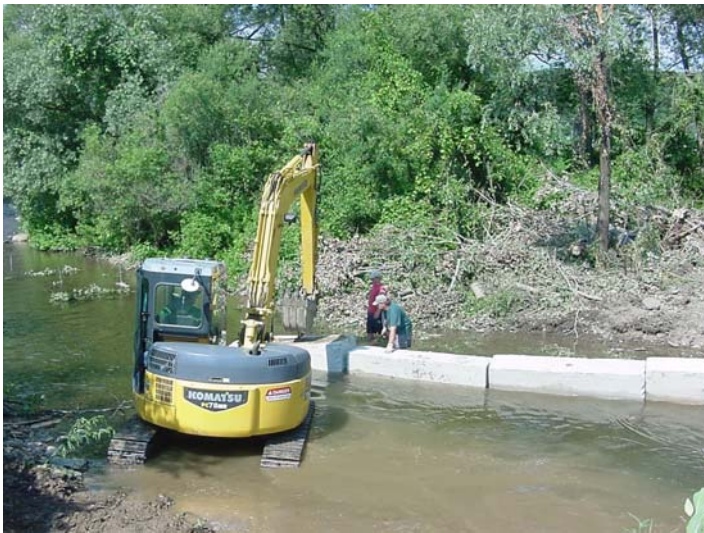
Concrete barriers are placed in the channel to divert the flow into the preexisting overflow channel during construction.

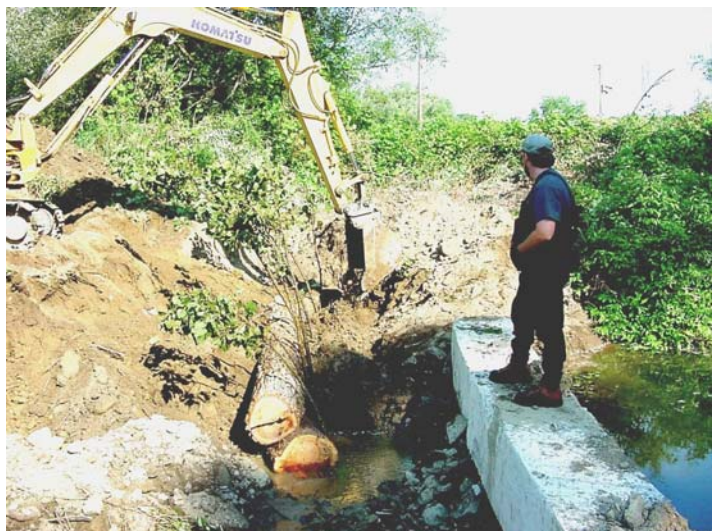
A tree trunk is placed back in the bank to serve as a tieback key. Live stakes are planted as well.

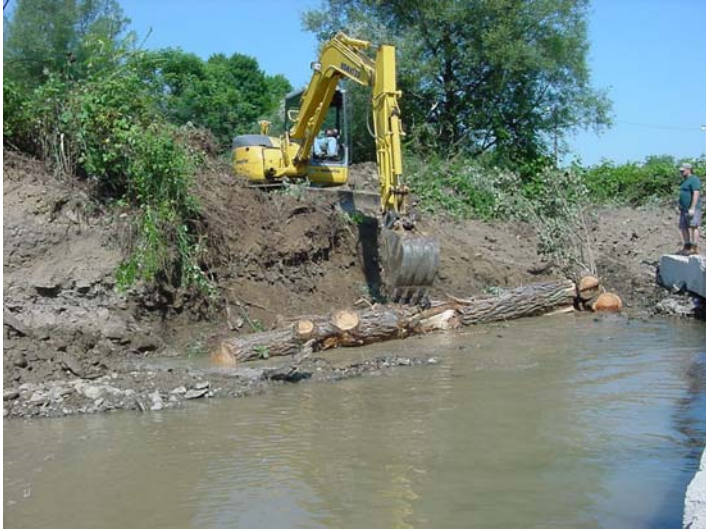
The excavator lowers the large tree trunks, which are then secured with cable to another log buried in the streambank.

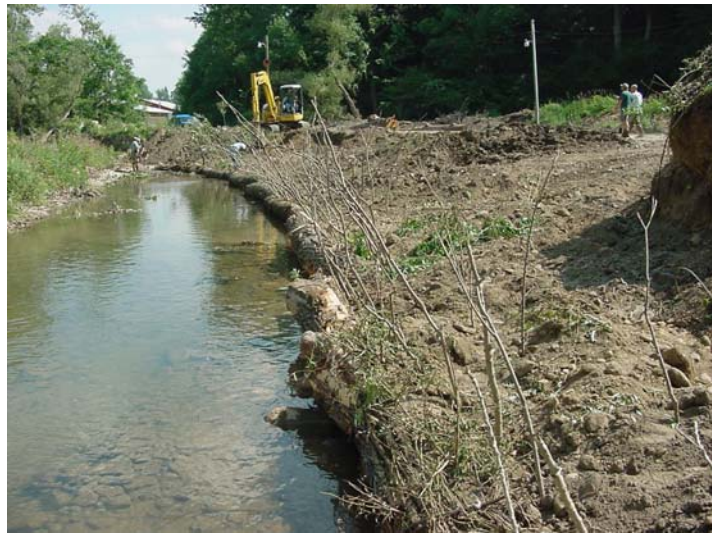
Looking downstream, the new revetments are visible, as are the live stakes. The floodplain is now gently sloped, rather than vertical.

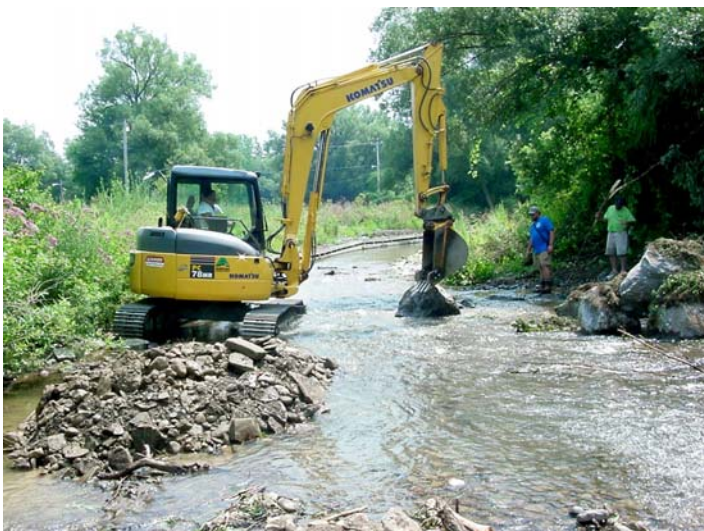
Using large rocks, a grade control structure is created, to prevent stream down cutting.

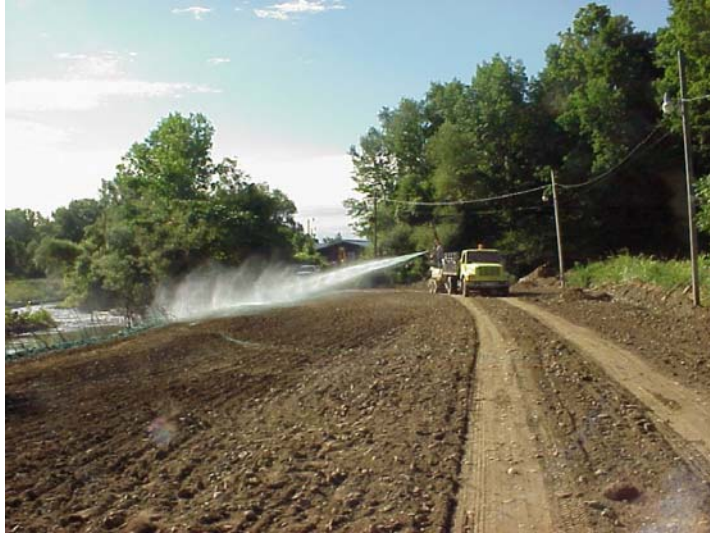
The newly constructed flood-plain is hydroseeded.

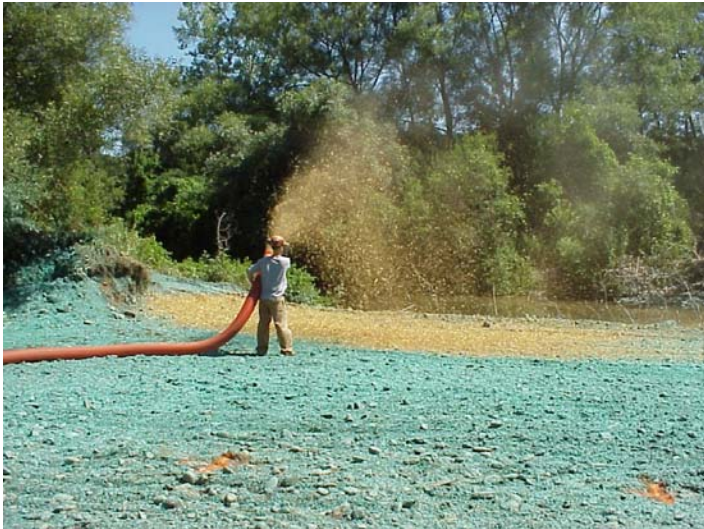
The hydroseeding is covered with a straw mulch.

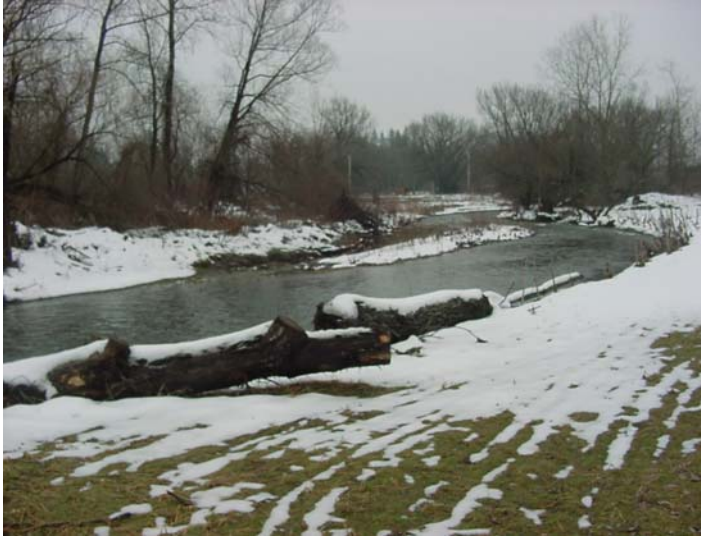
The January flood damage.

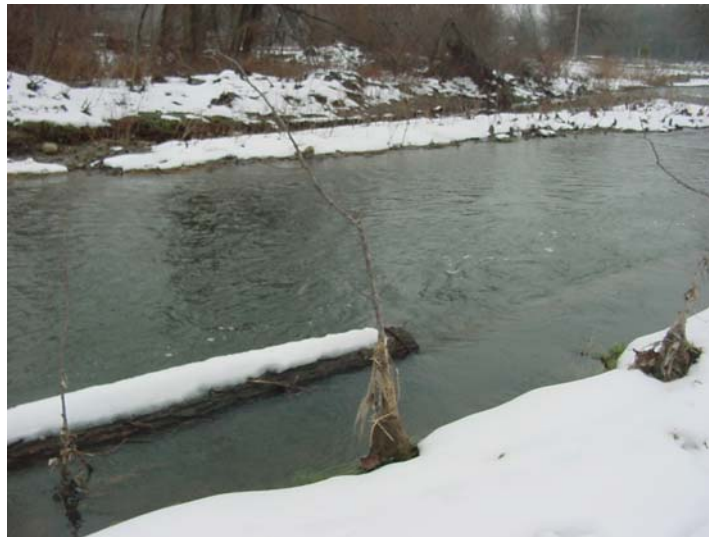
Revetments under high water
during January.

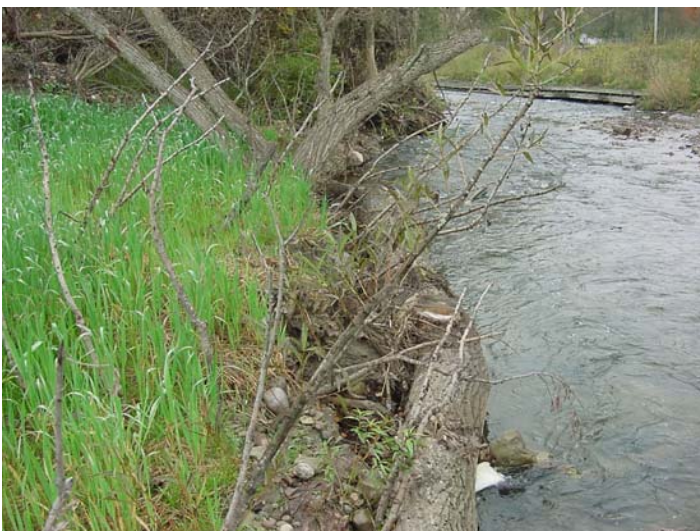
Before repairs are made to
the revetments.

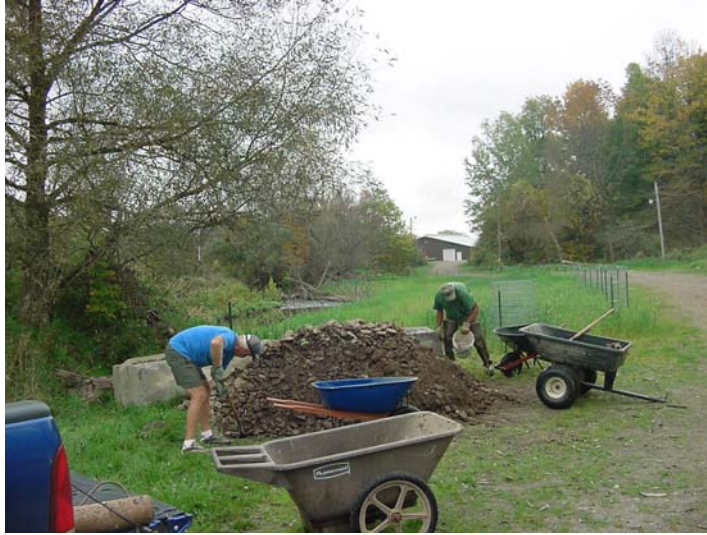
Starting repairs from winter
flooding.

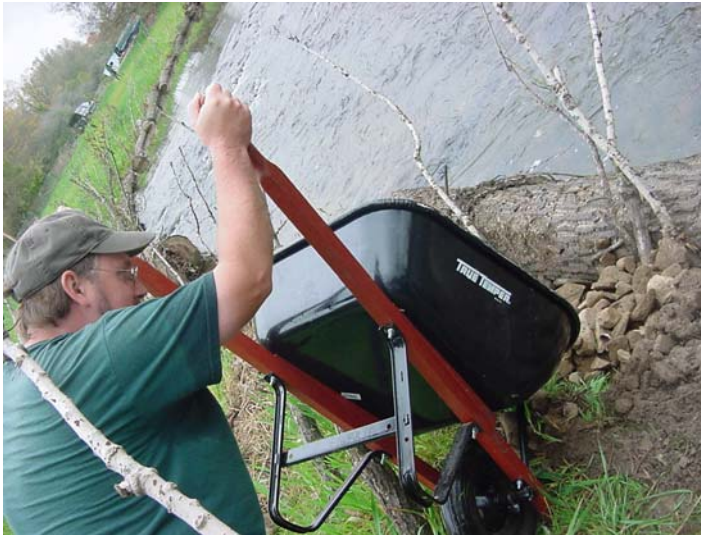
Placing rock behind
revetments.

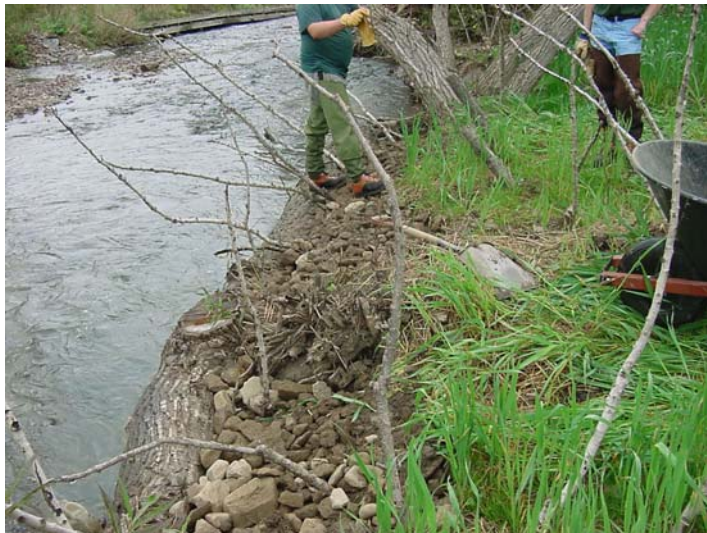
Repair rock in place.

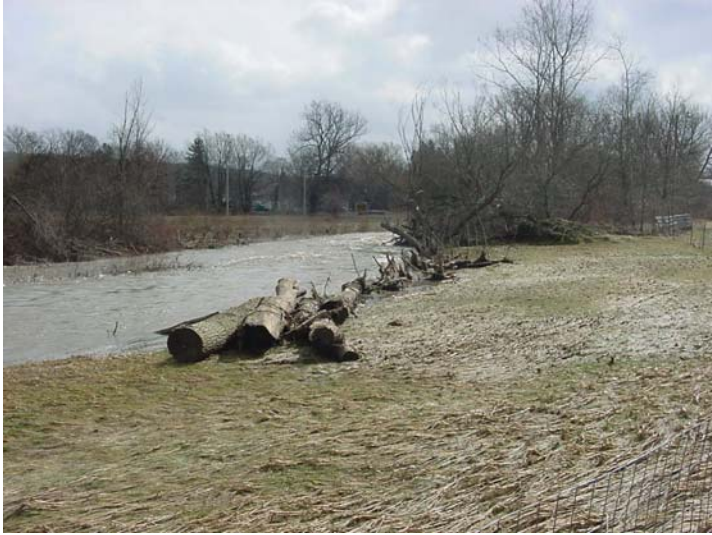
Revetments steel cabled together, but pushed on bank.

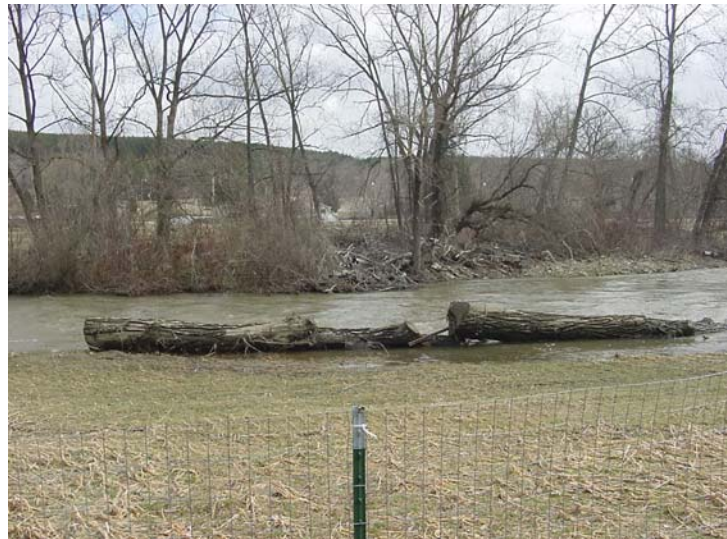
High water rolls revetments onto bank.

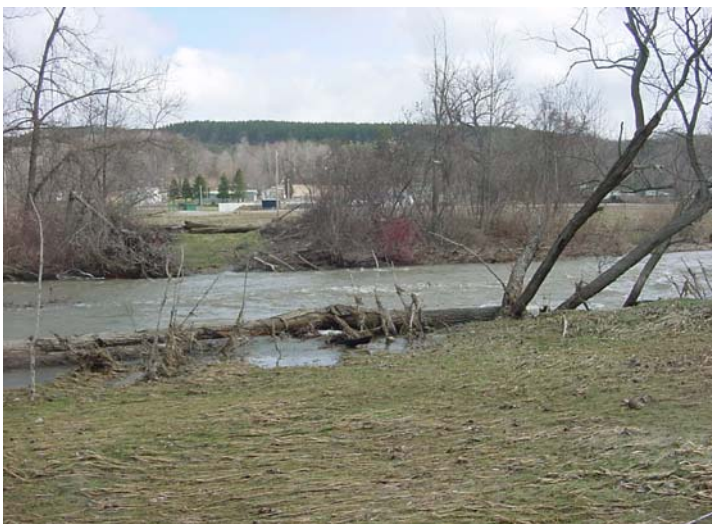
Last revetments held under the high water.

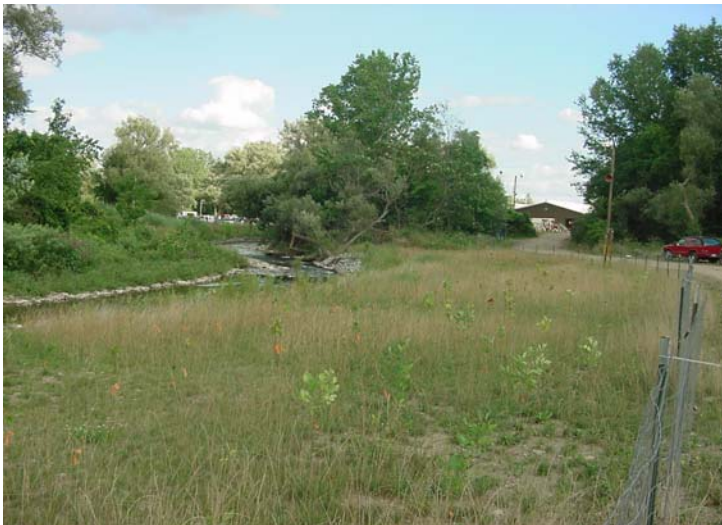
Completed streambank with
planted trees.
